Section 5 Attachment
Abandoned Sump Photo Chronology

2.9 PHOTOGRAPHIC CHRONOLOGY

The following photographs document construction completed by the subject Interim Measures Construction Project. The descriptive text below is identified with the corresponding photograph number and date (**imprinted in the lower right corner of each photo, unless indicated otherwise**).

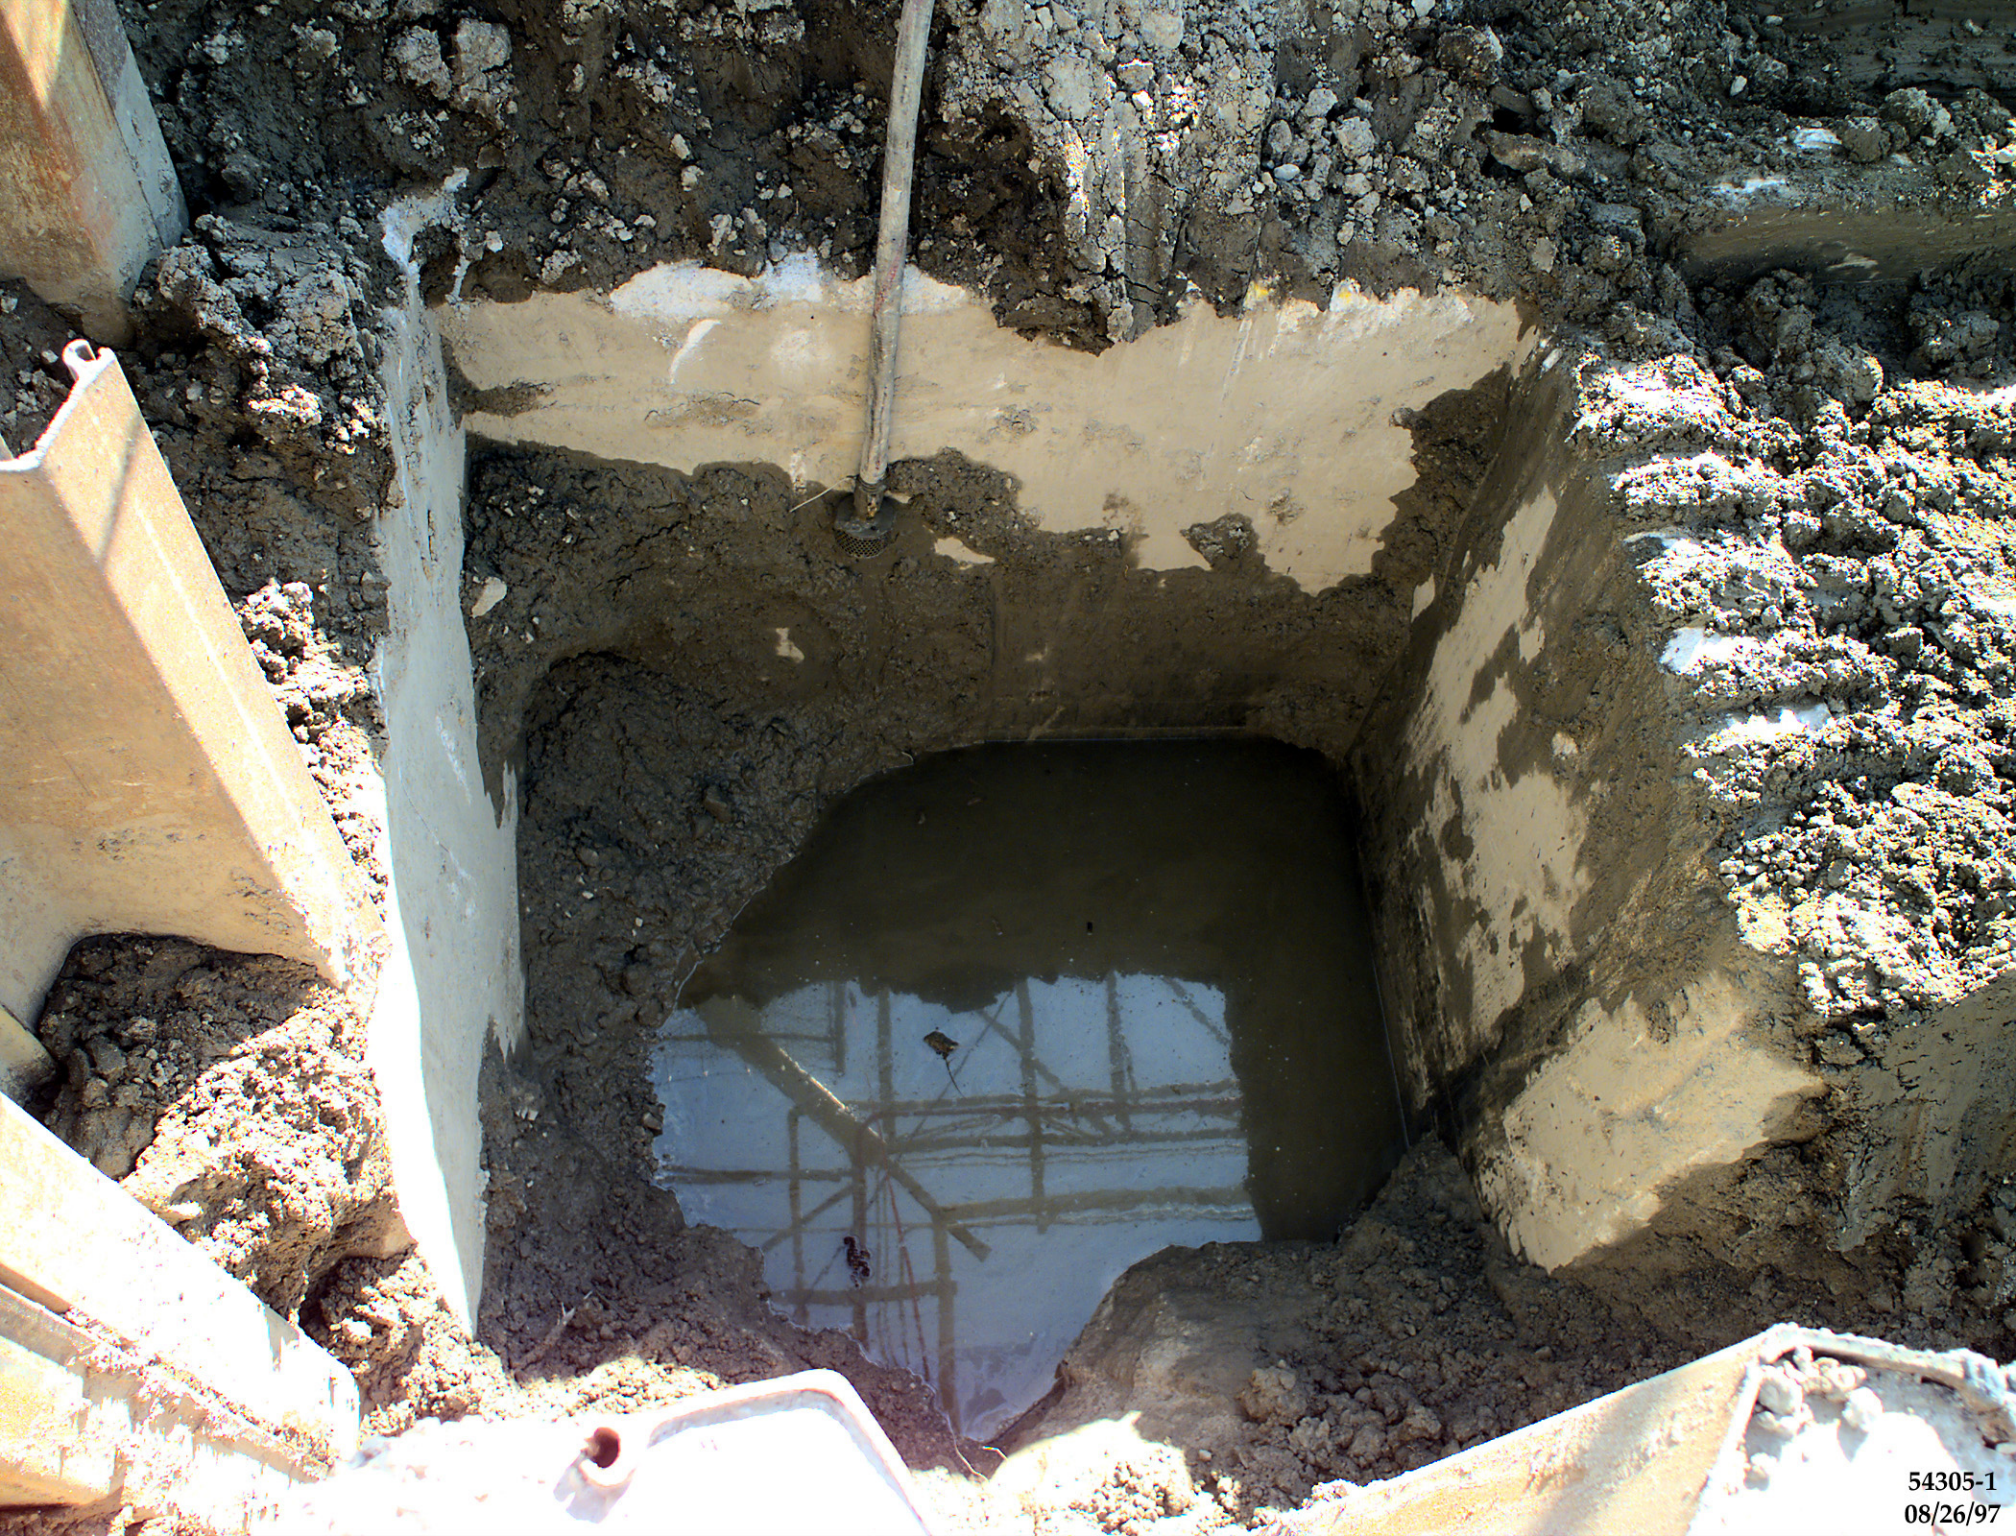
Photograph #54305-01, 08/26/97

This photograph was taken facing east from the top of Twr 10, looking down into Zone A. This photo shows the sheet piling that was installed to protect the firemain and the Twr 10 footing. The suction hose in the center of the photo was used for dewatering Zone A. The water was pumped to a temporary treatment system which used carbon to remove detectable PCBs and VOCs. The overhead piping supported by Twr 10 is shown reflected in the water in Zone A.

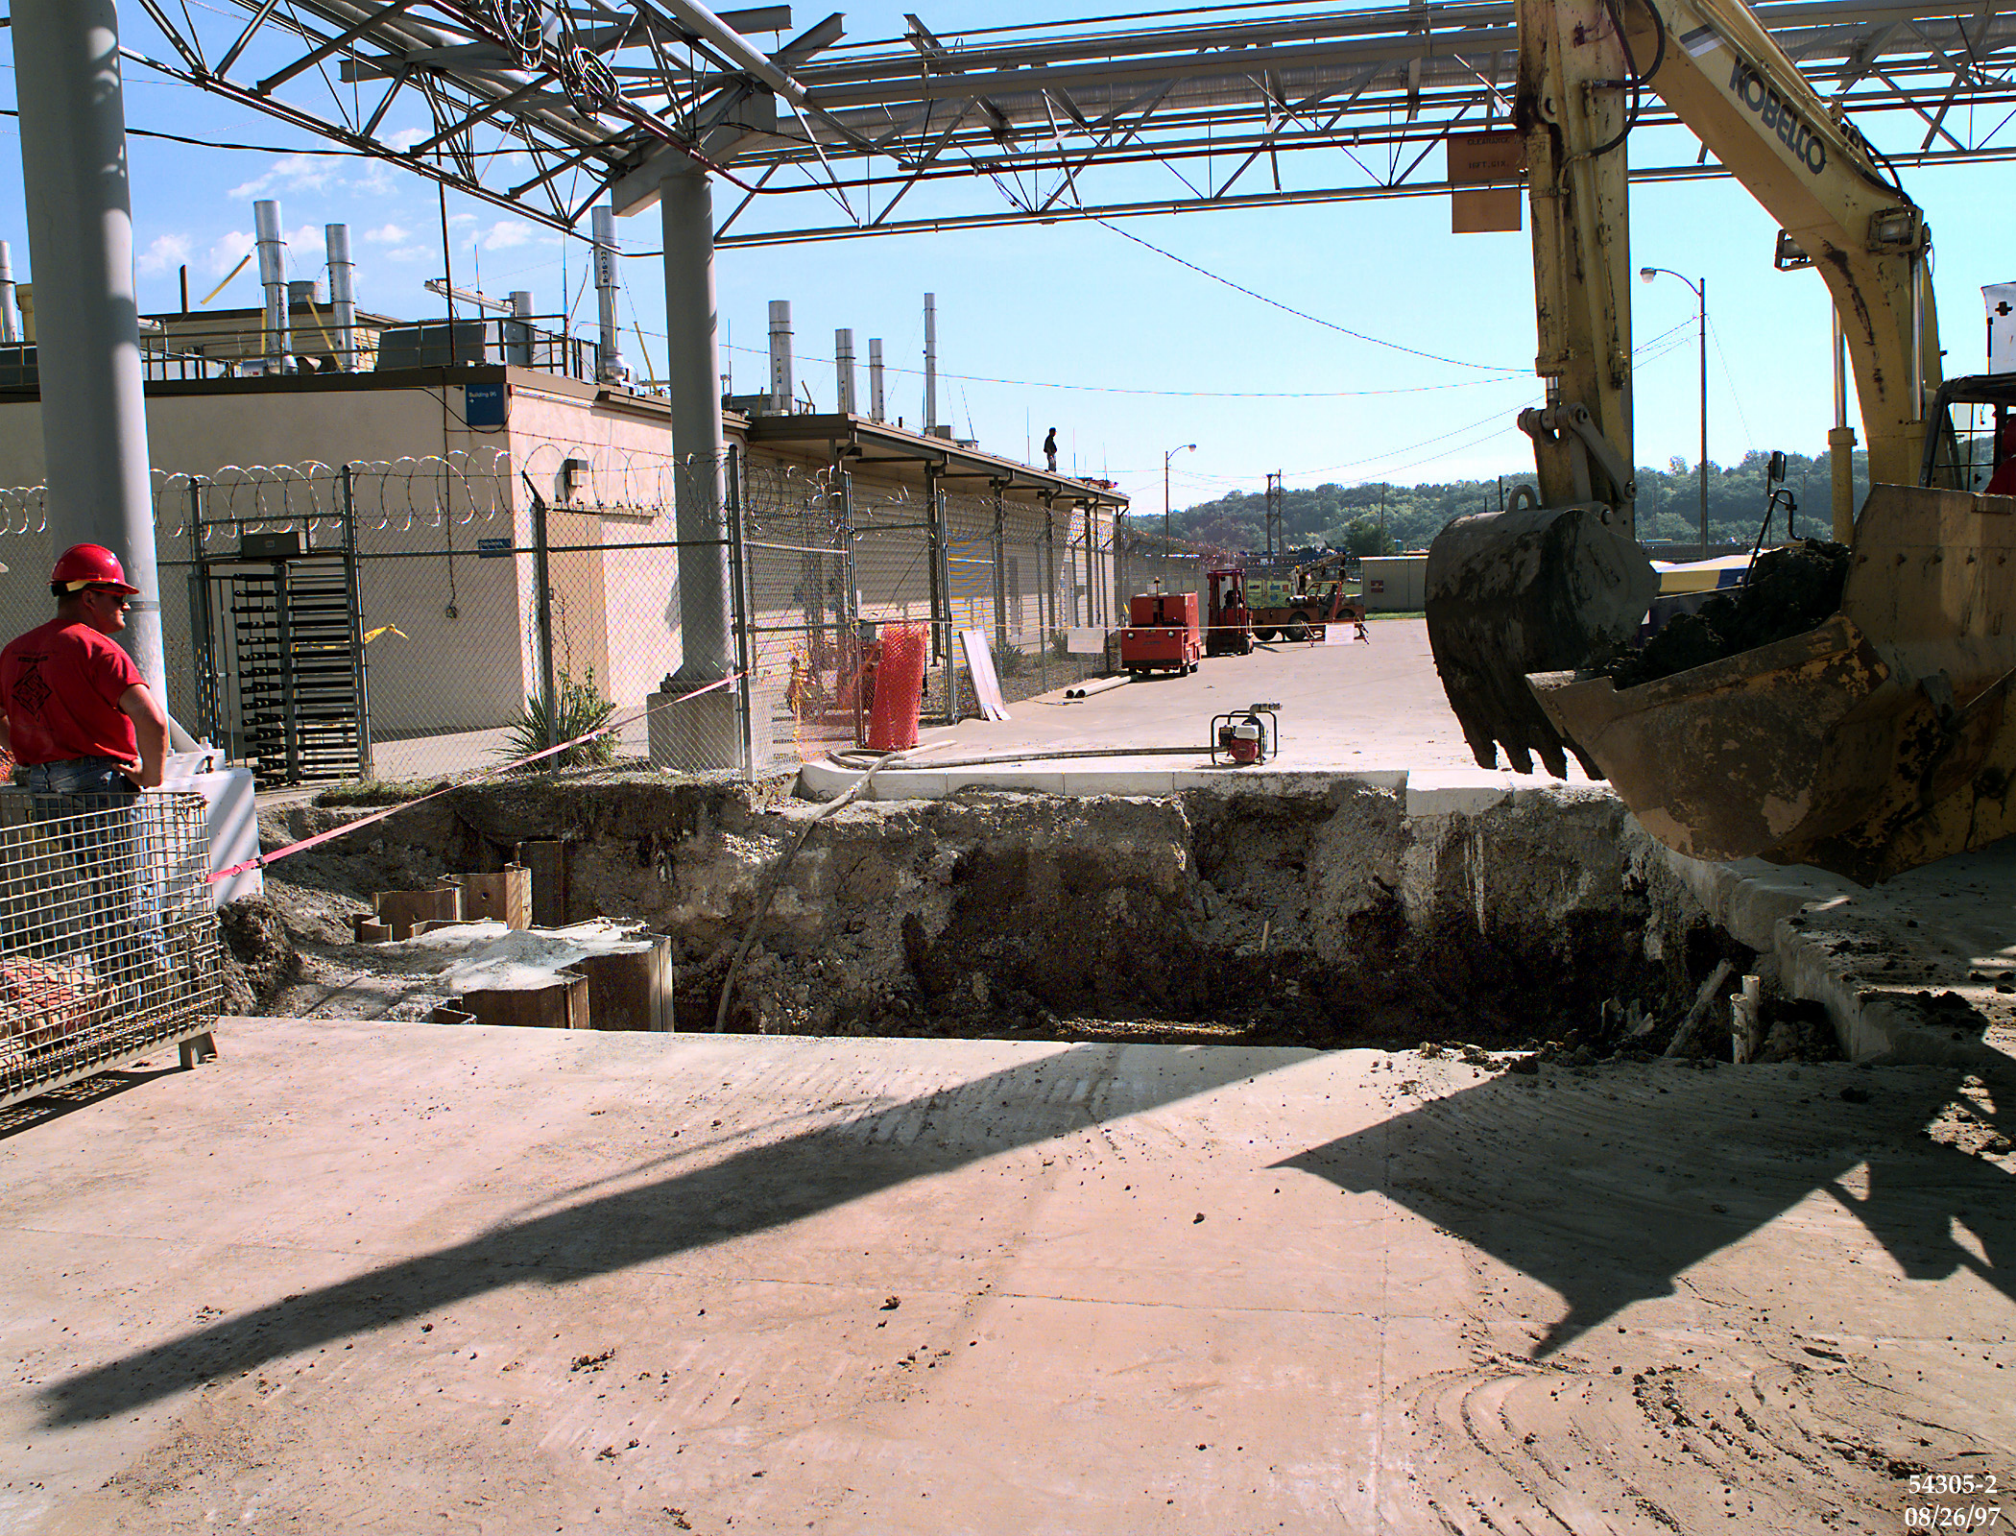
Photograph #54305-02, 08/26/97

This photograph was taken facing east over the South excavation area.

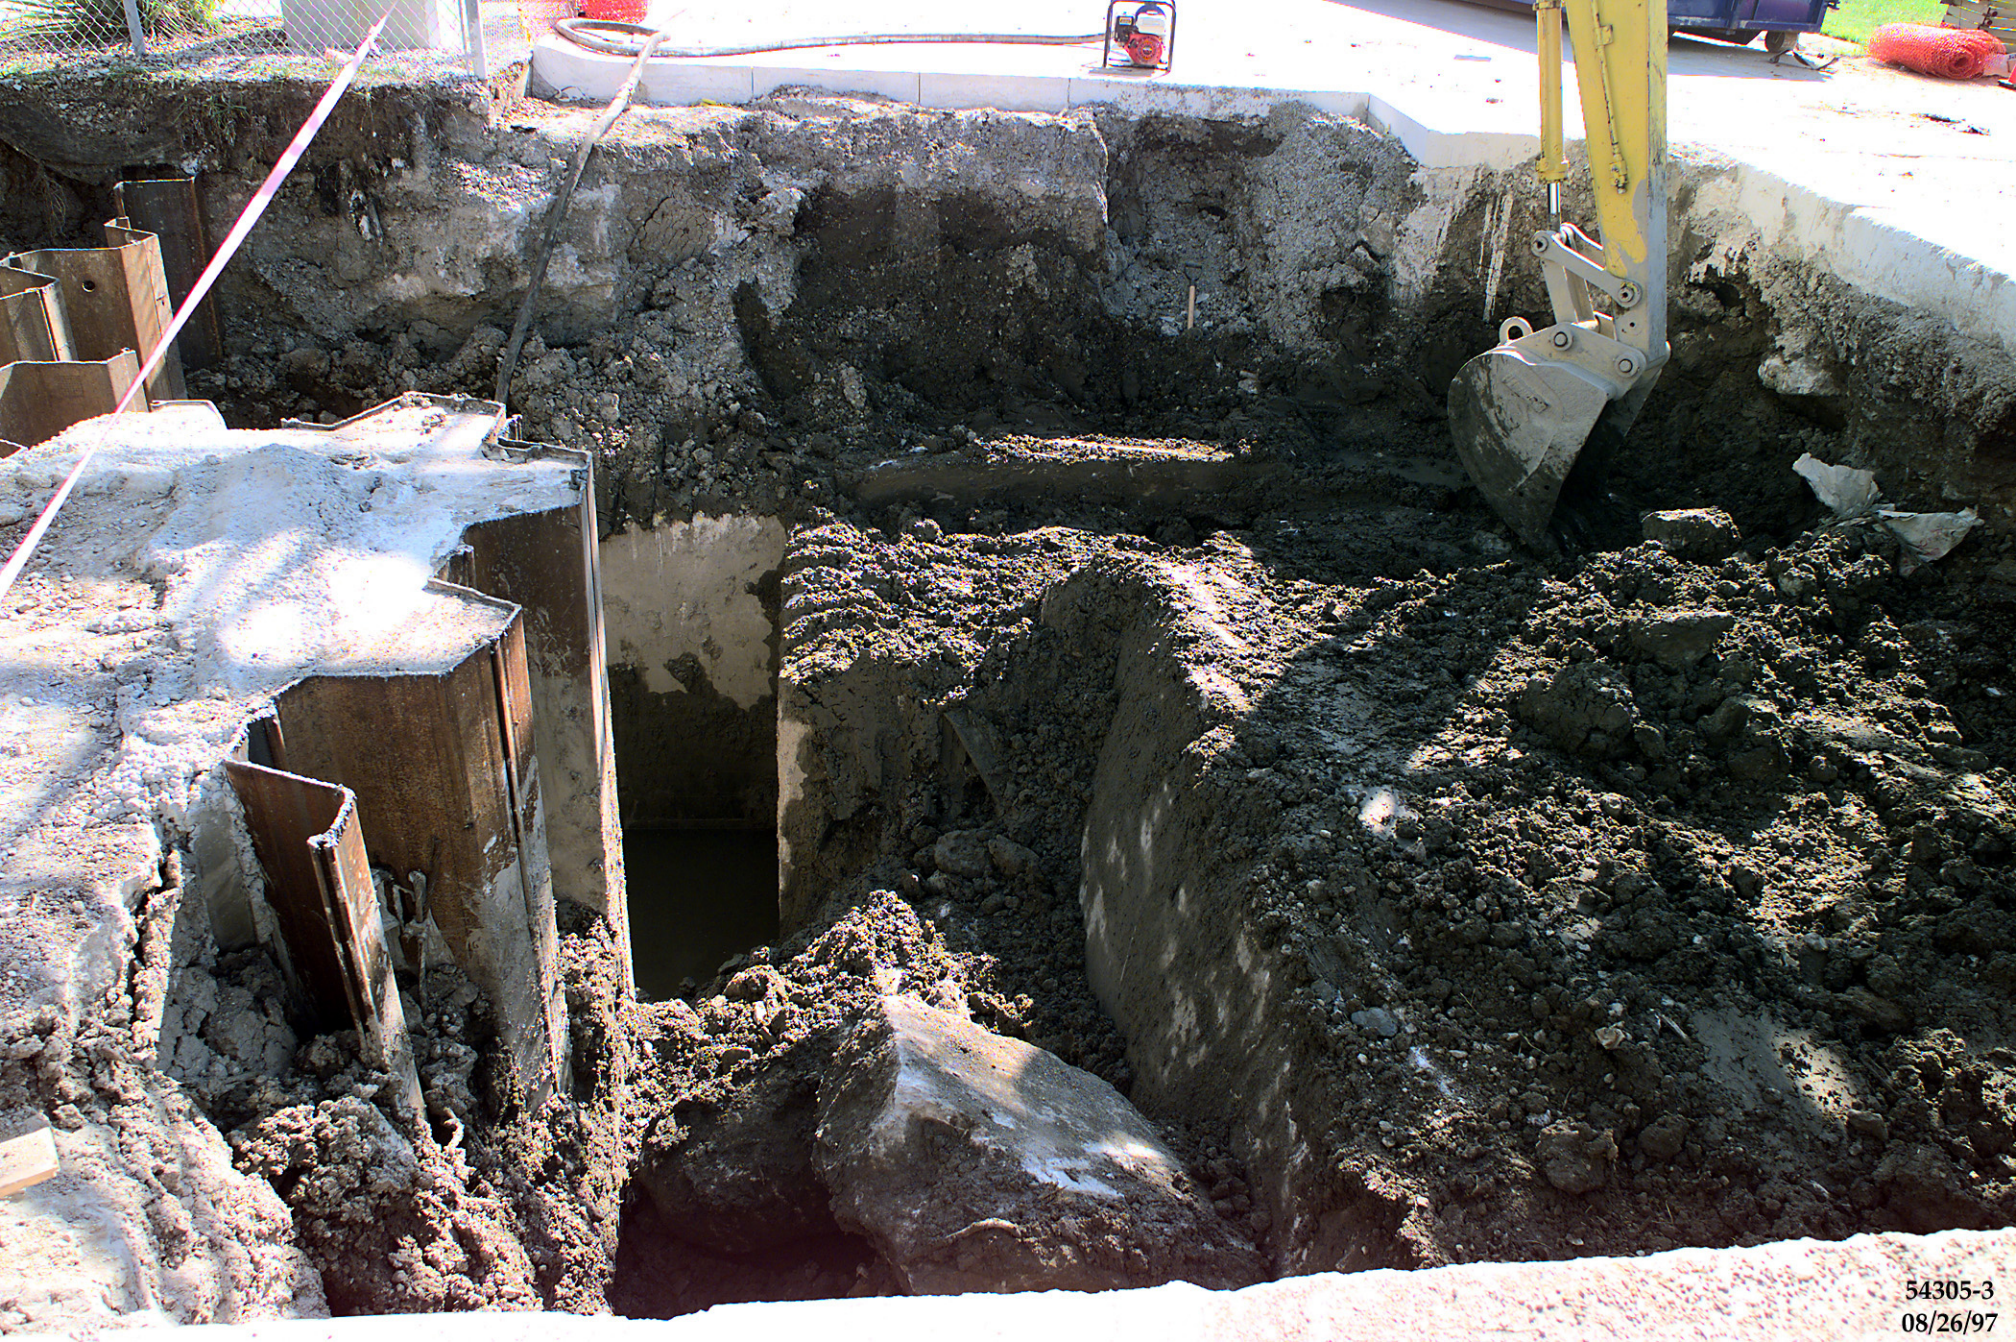
54305-3
08/26/97

This photograph was taken facing east over the South excavation area, looking into Zone B as the walls of the sump structure are uncovered.

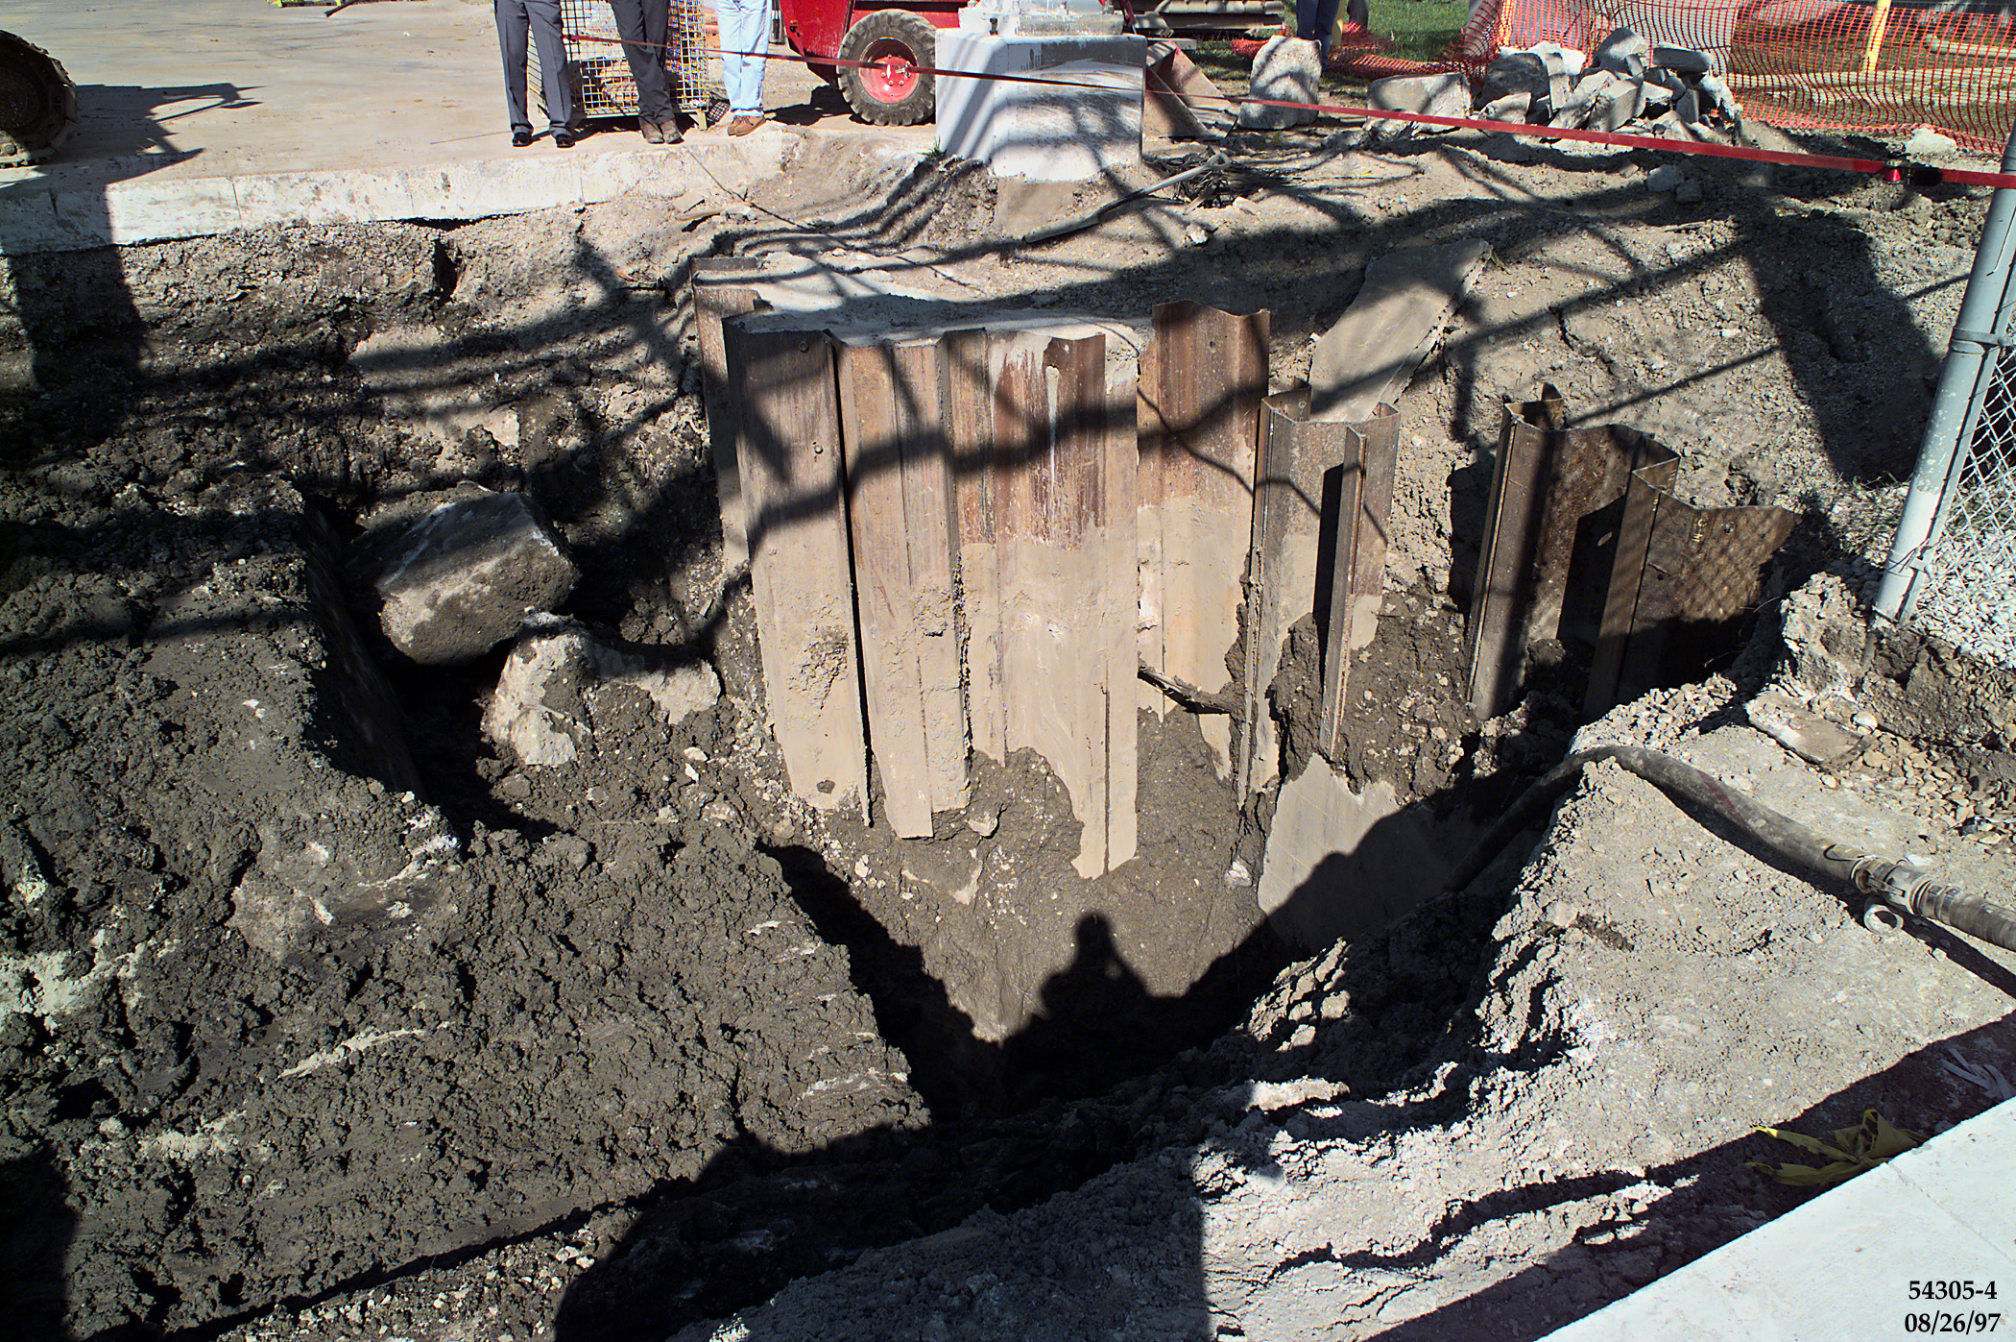
54305-4
08/26/97

This photograph was taken facing west over the South excavation area, looking into Zone A & B as the walls of the sump structure are uncovered.

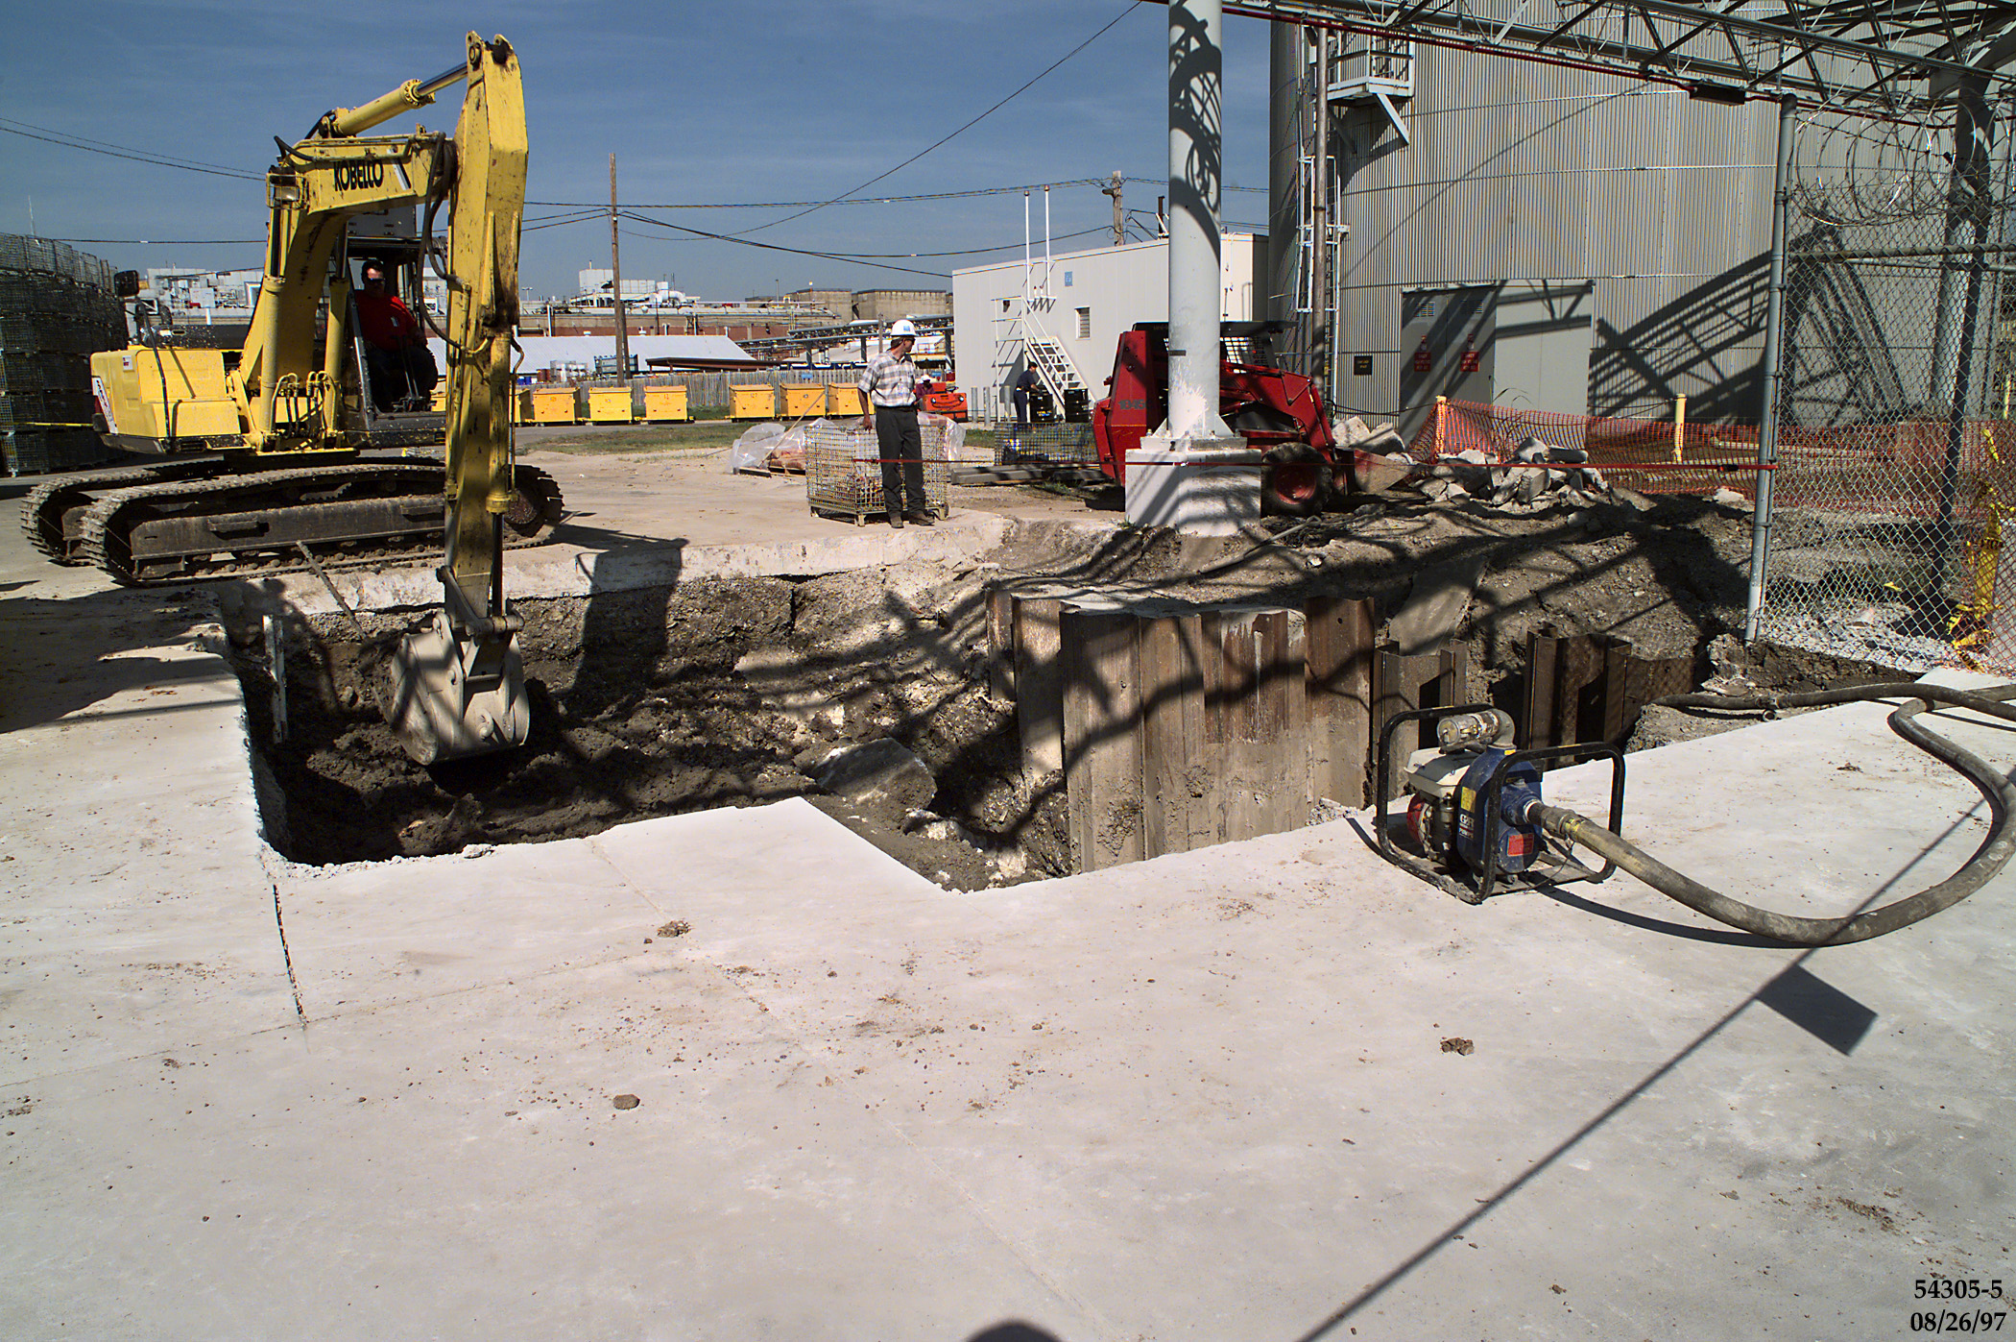
Photograph #54305-5, 08/26/97

This photograph was taken facing west over the South excavation area, as the walls of the sump structure are uncovered.

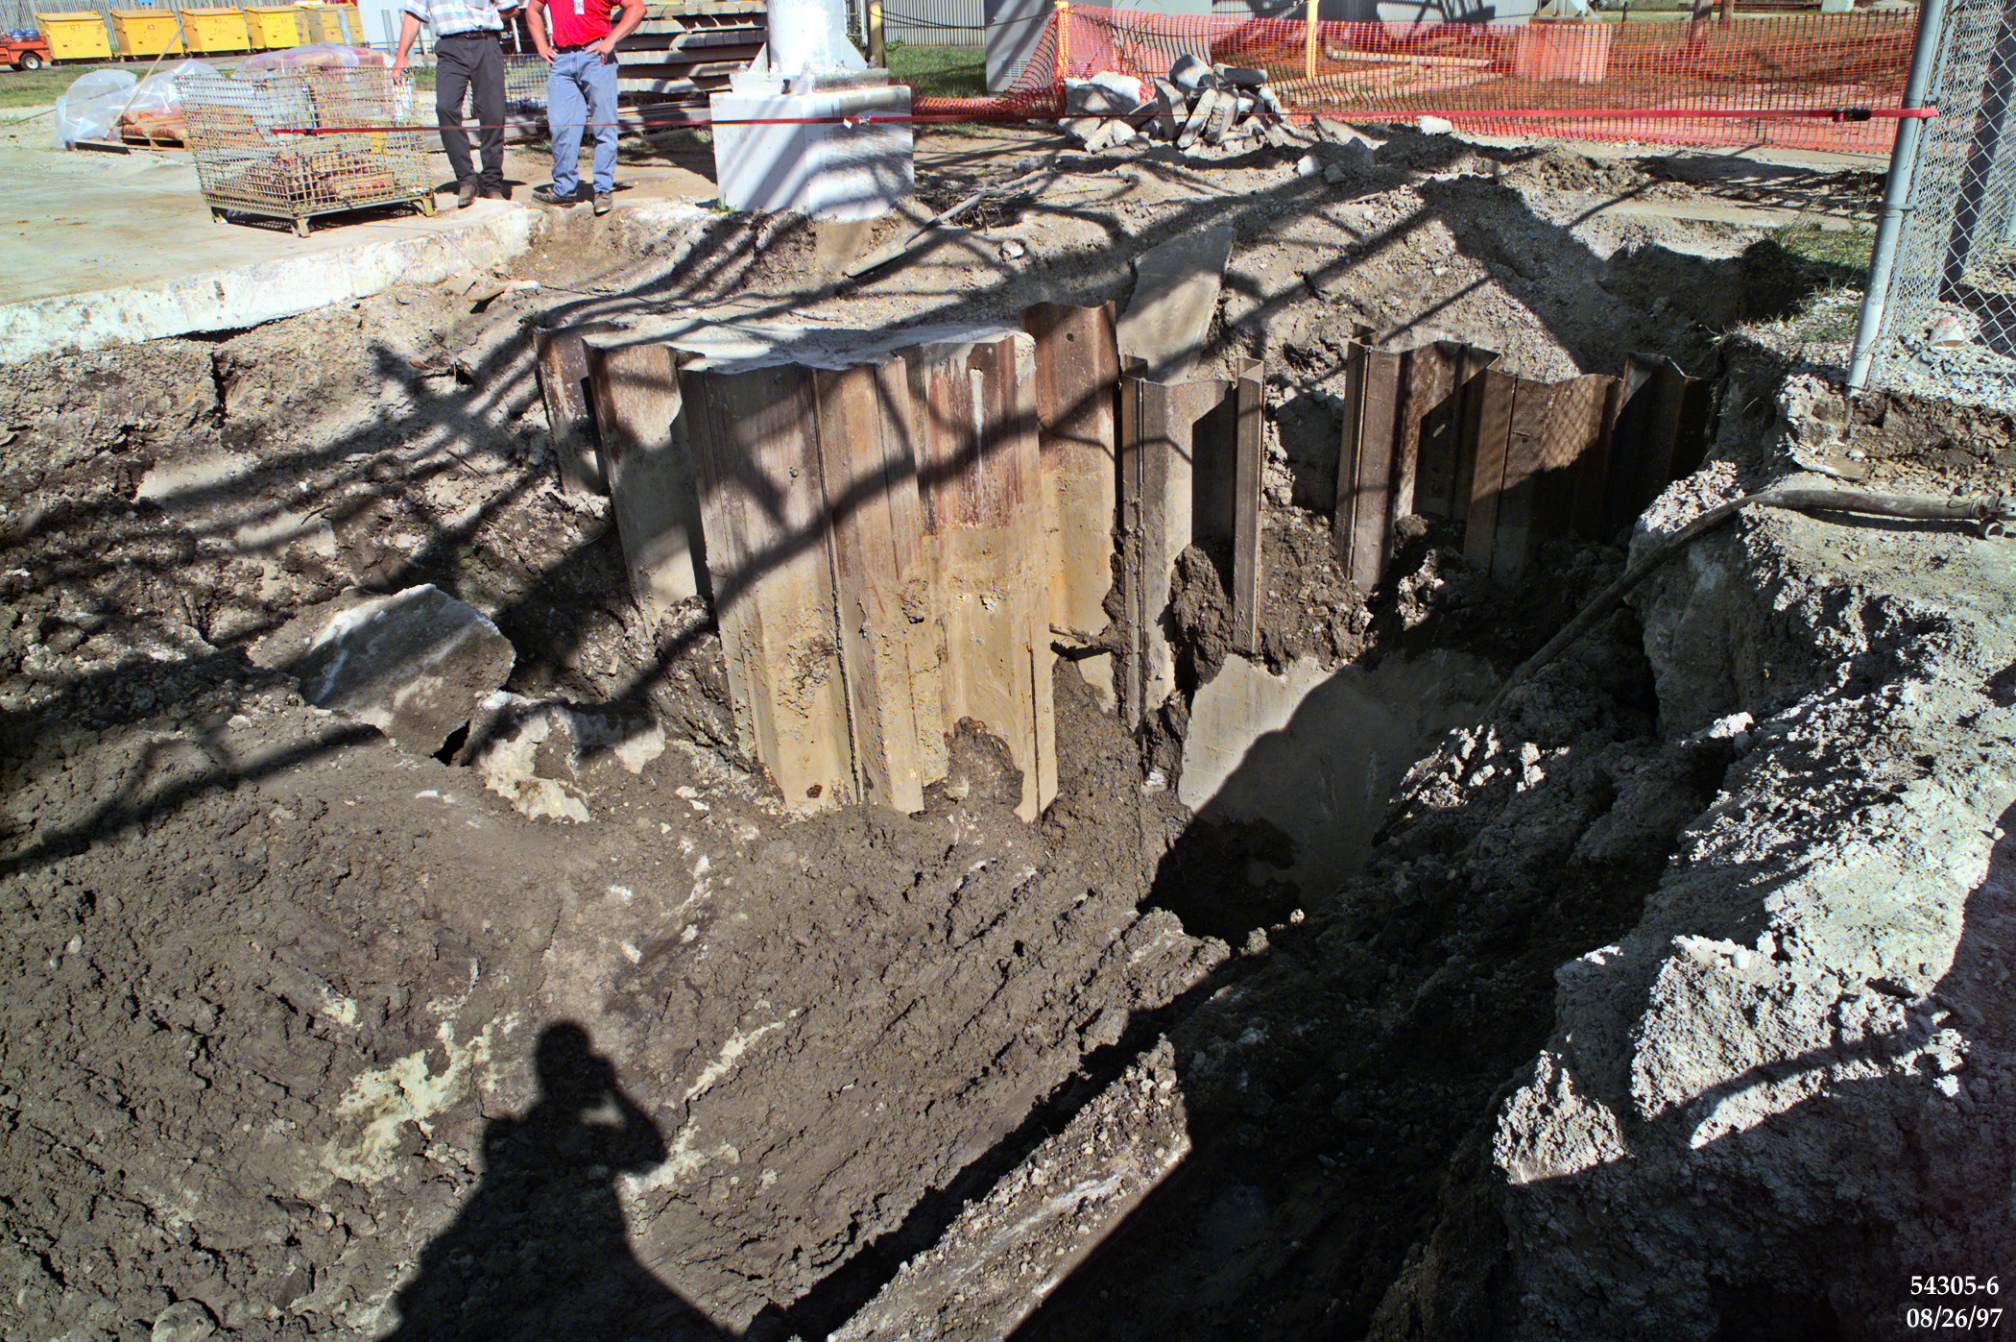
Photograph #54305-6, 08/26/97

This photograph was taken facing northwest over the South excavation area, as the walls of the sump structure are uncovered. Notice the large concrete rubble in the left side of the excavation. Massive pieces of concrete were found in the top four feet over the sump structure. It appears that concrete was pour over the site to stabilize the roadbed after the demolition of the sump structure (or whatever building this was).

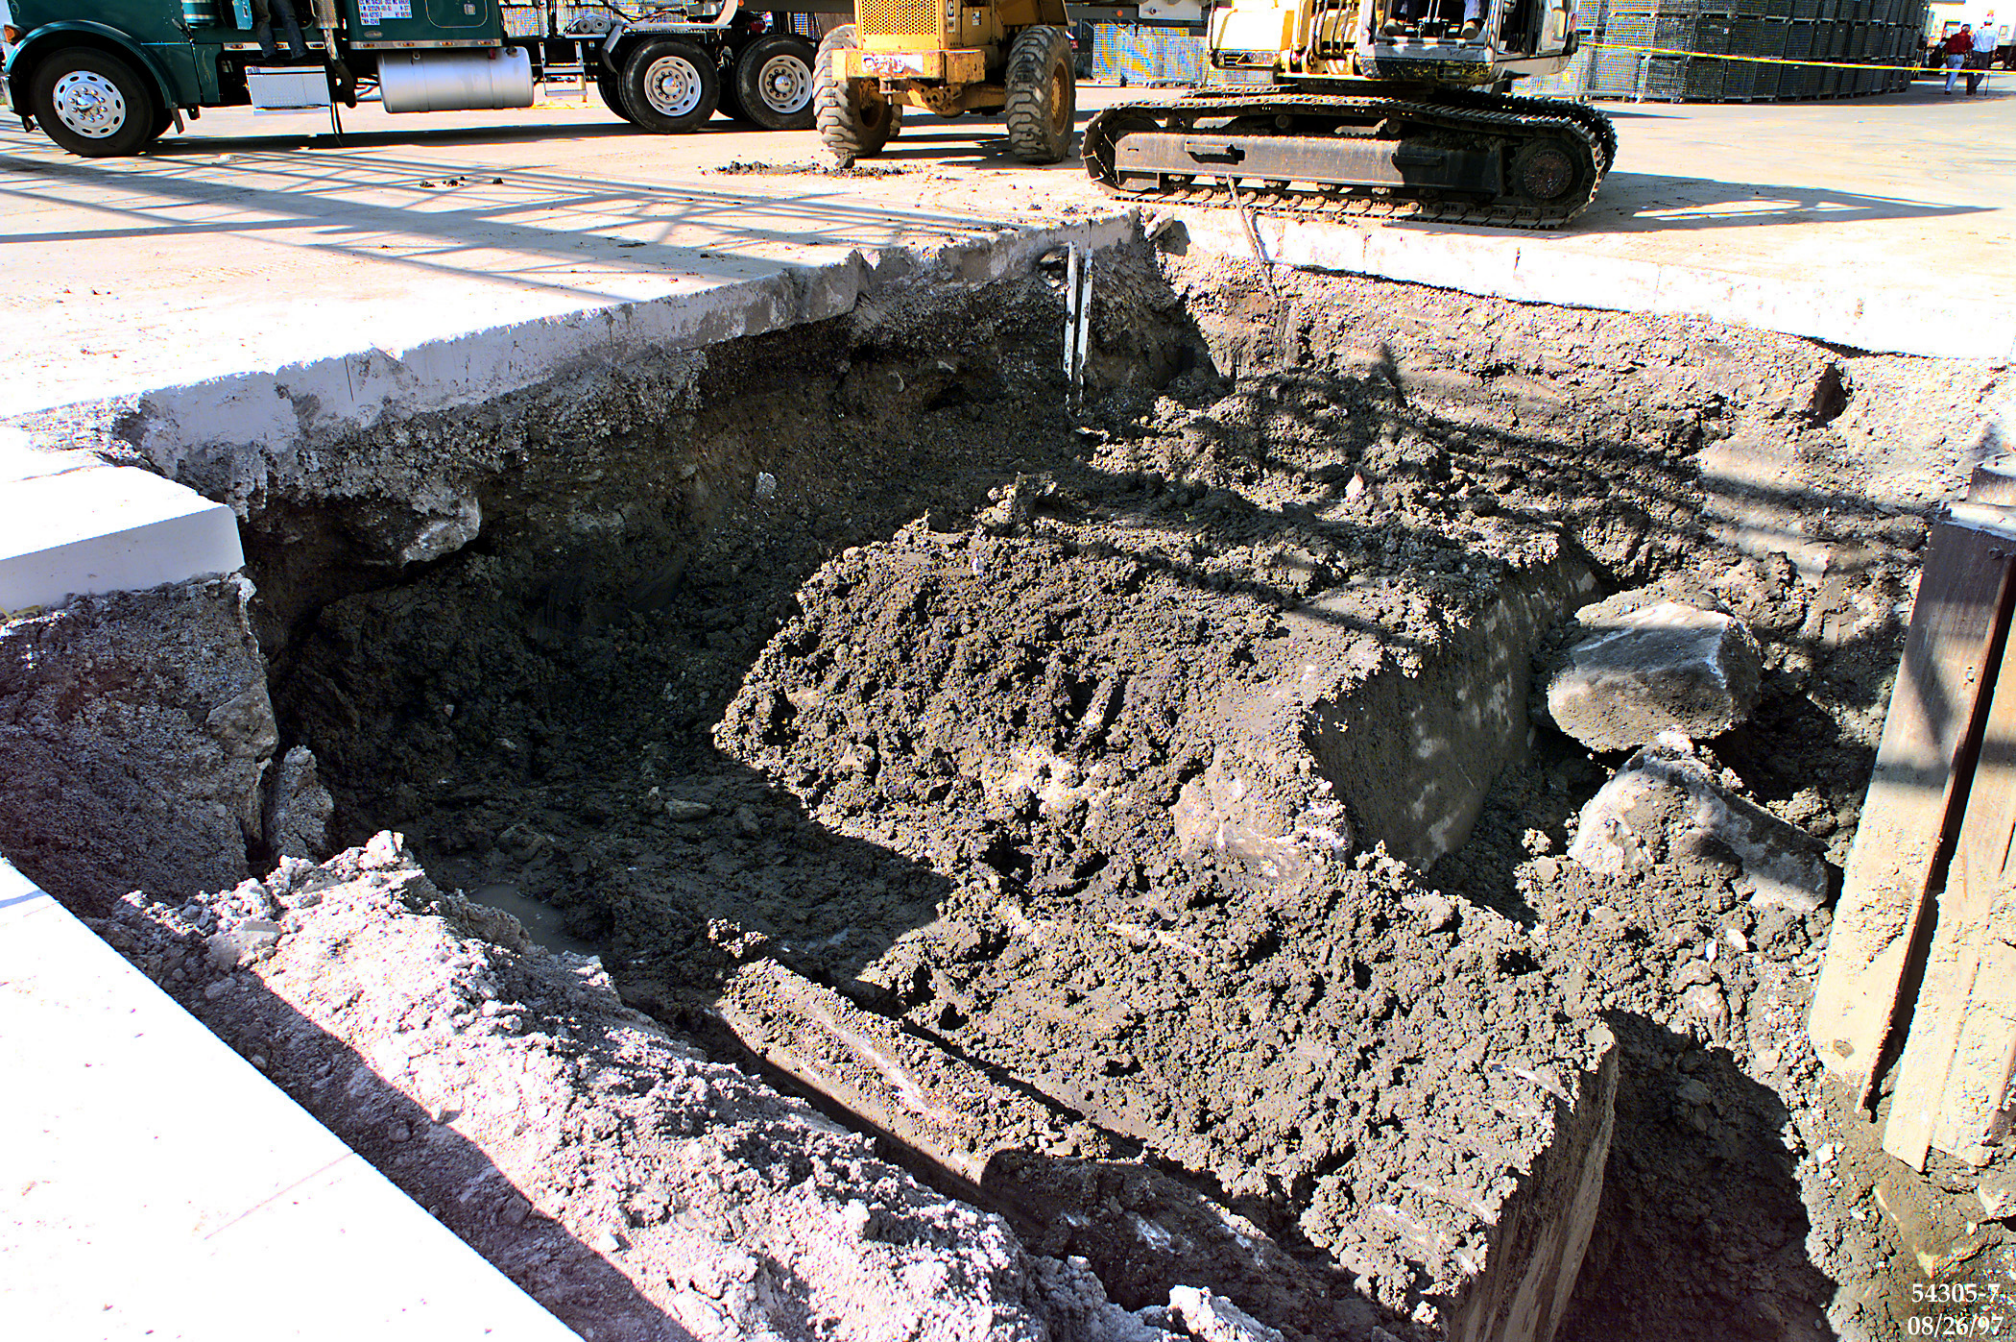
54305-7
08/26/97

This photograph was taken facing southwest over the South excavation area, as the walls of the sump structure are uncovered.

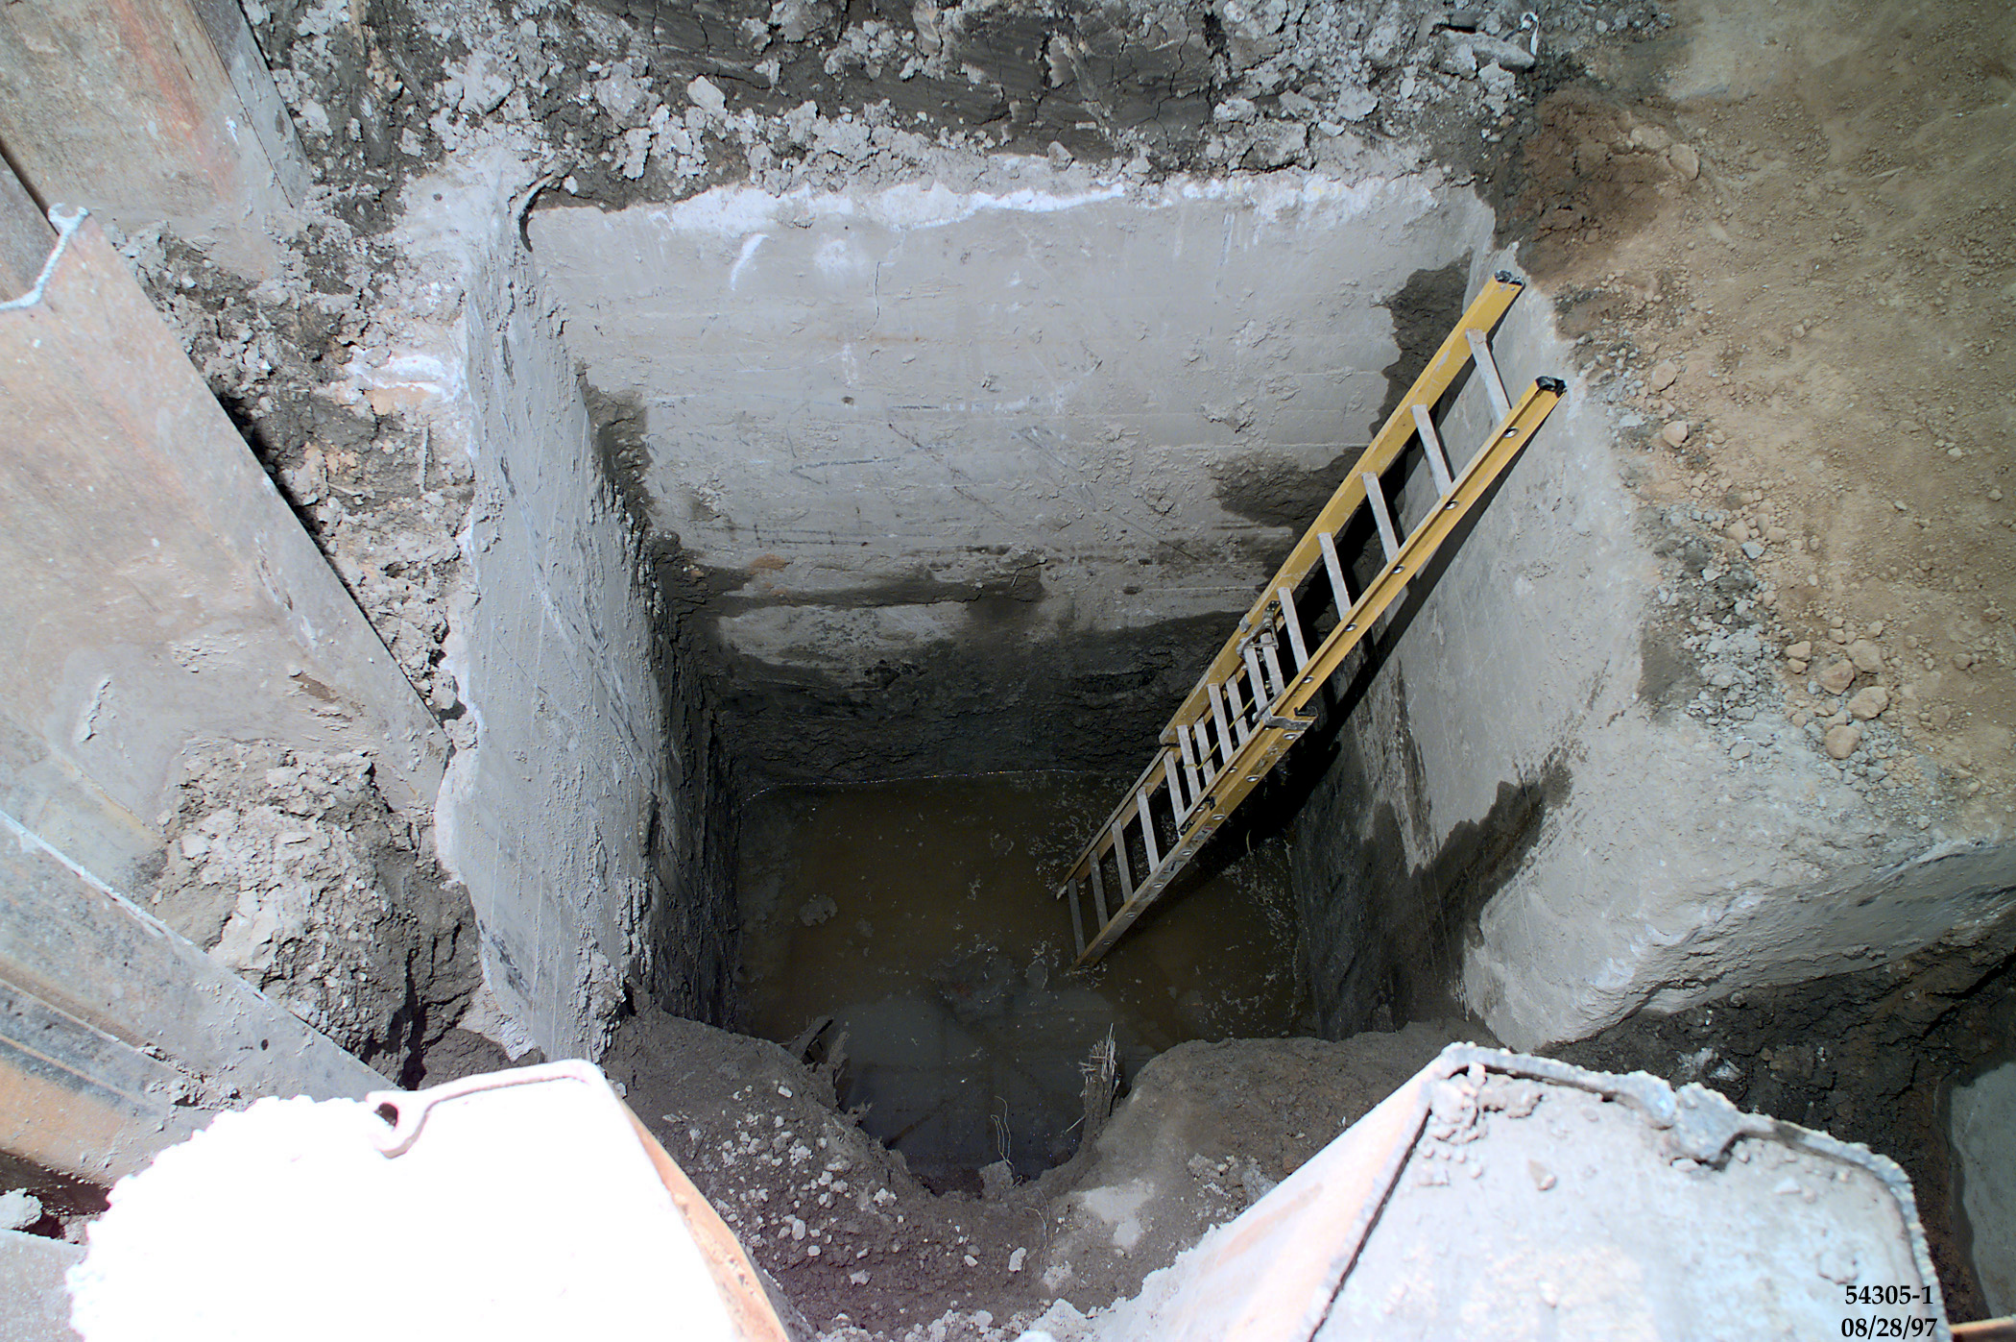
54305-1
08/28/97

This photograph was taken facing east from the top of Twr 10, looking down into Zone A. This photo shows the sheet piling that was installed to protect the firemain and the Twr 10 footing. The ladder was used for collecting a soil sample from the bottom of Zone A (about 20 feet below the ground surface). The water was pumped to a temporary treatment system which used carbon to remove detectable PCBs and VOCs.
