Section 5 Attachment
Abandoned Sump Photo Chronology

2.9 PHOTOGRAPHIC CHRONOLOGY

The following photographs document construction completed by the subject Interim Measures Construction Project. The descriptive text below is identified with the corresponding photograph number and date (**imprinted in the lower right corner of each photo, unless indicated otherwise**).

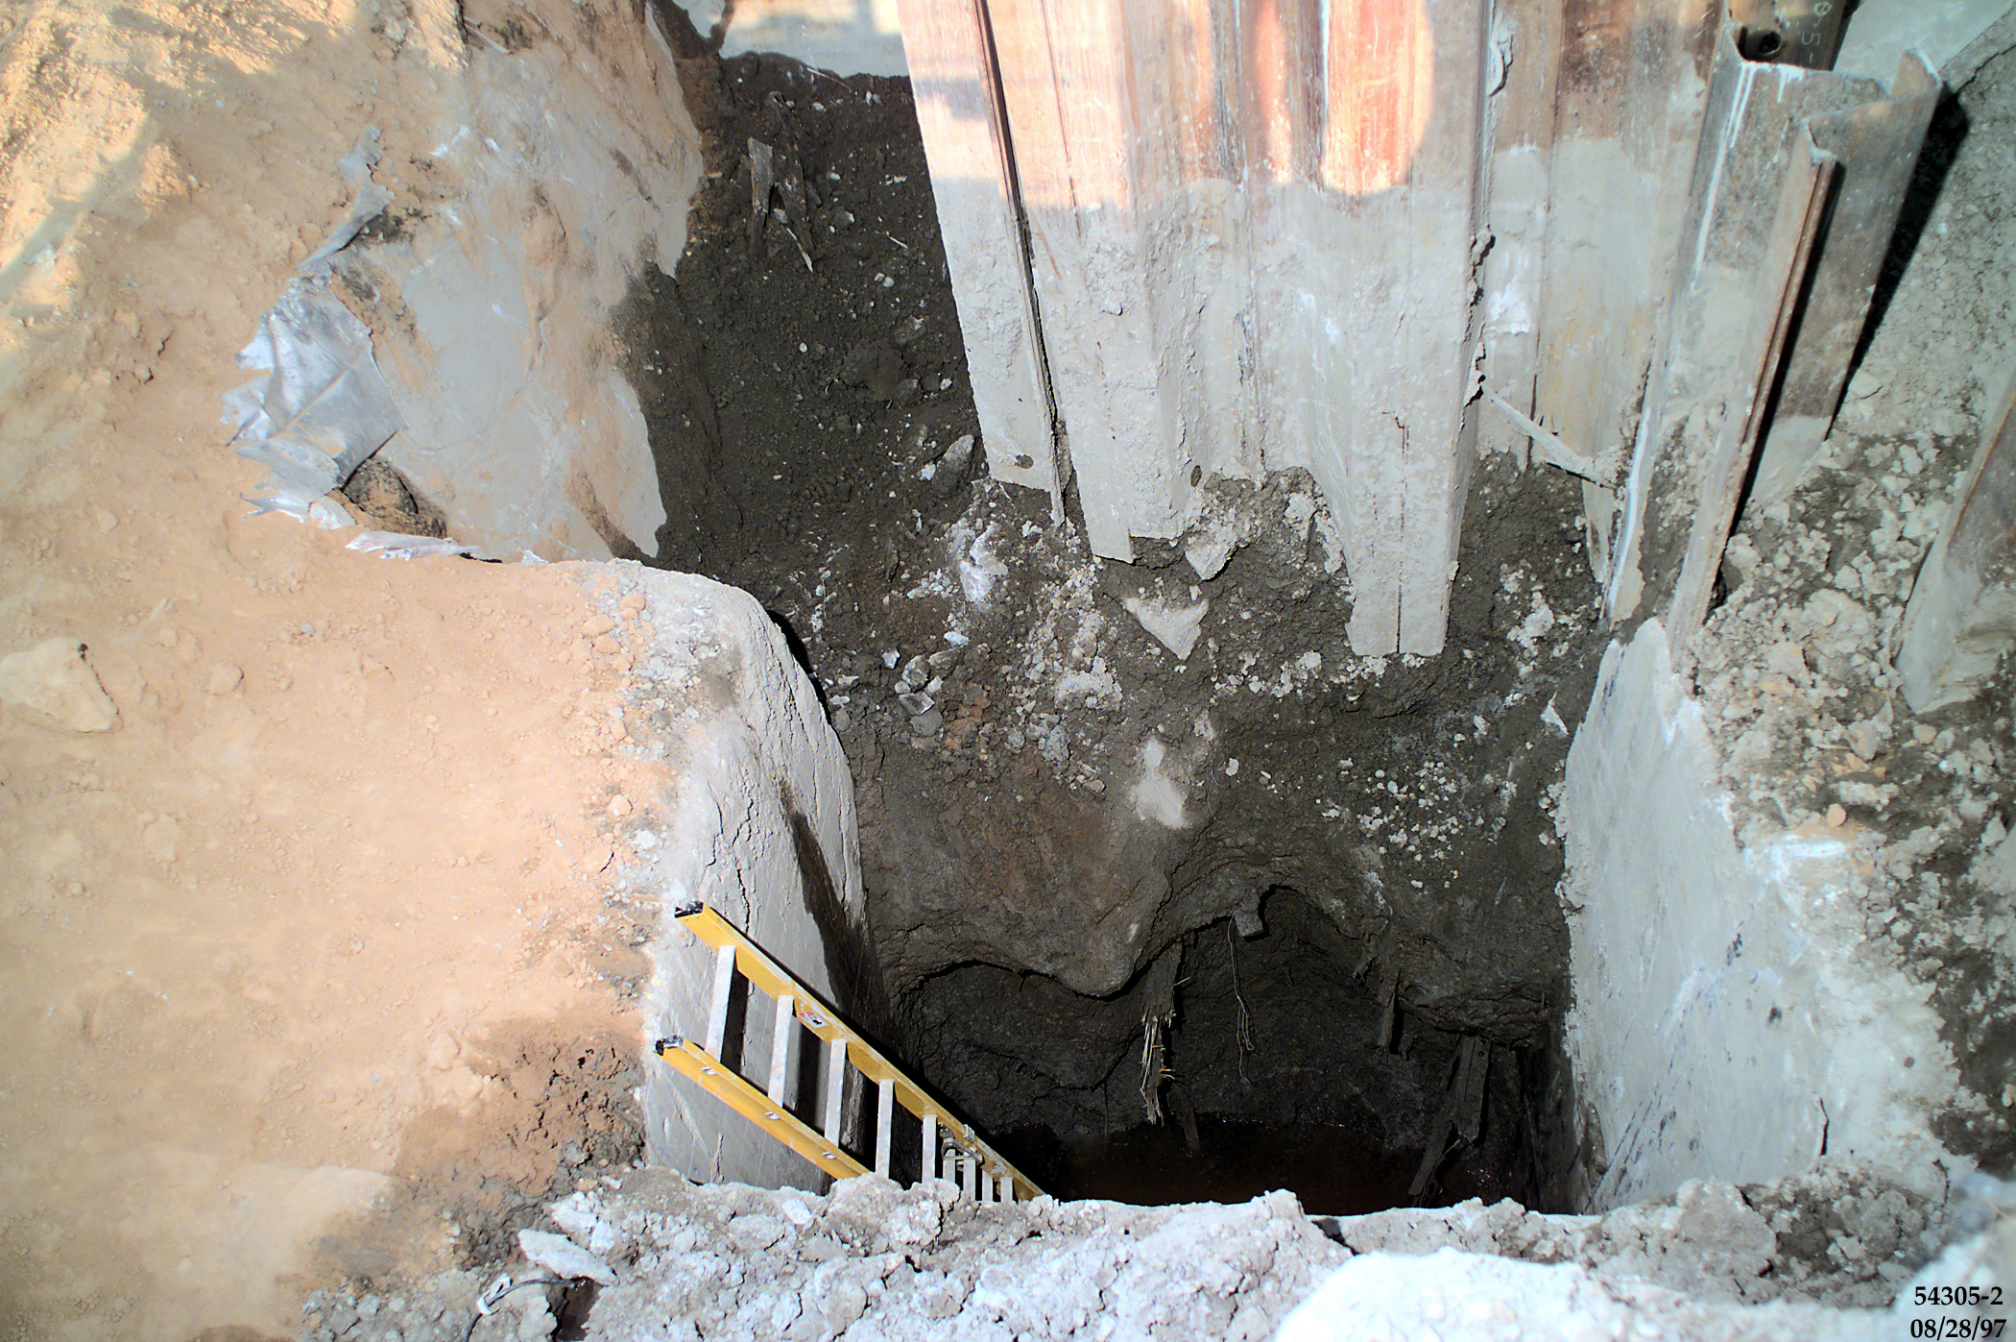
Photograph #54305-2, 08/28/97

This photograph was taken facing west, looking down into Zone A. This photo shows the sheet piling that was installed to protect the Twr 10 footing. Rubble beneath the sheet piles (that was left in place) is visible near the ladder. The ladder was used for collecting a soil sample from the bottom of Zone A (about 20 feet below the ground surface).

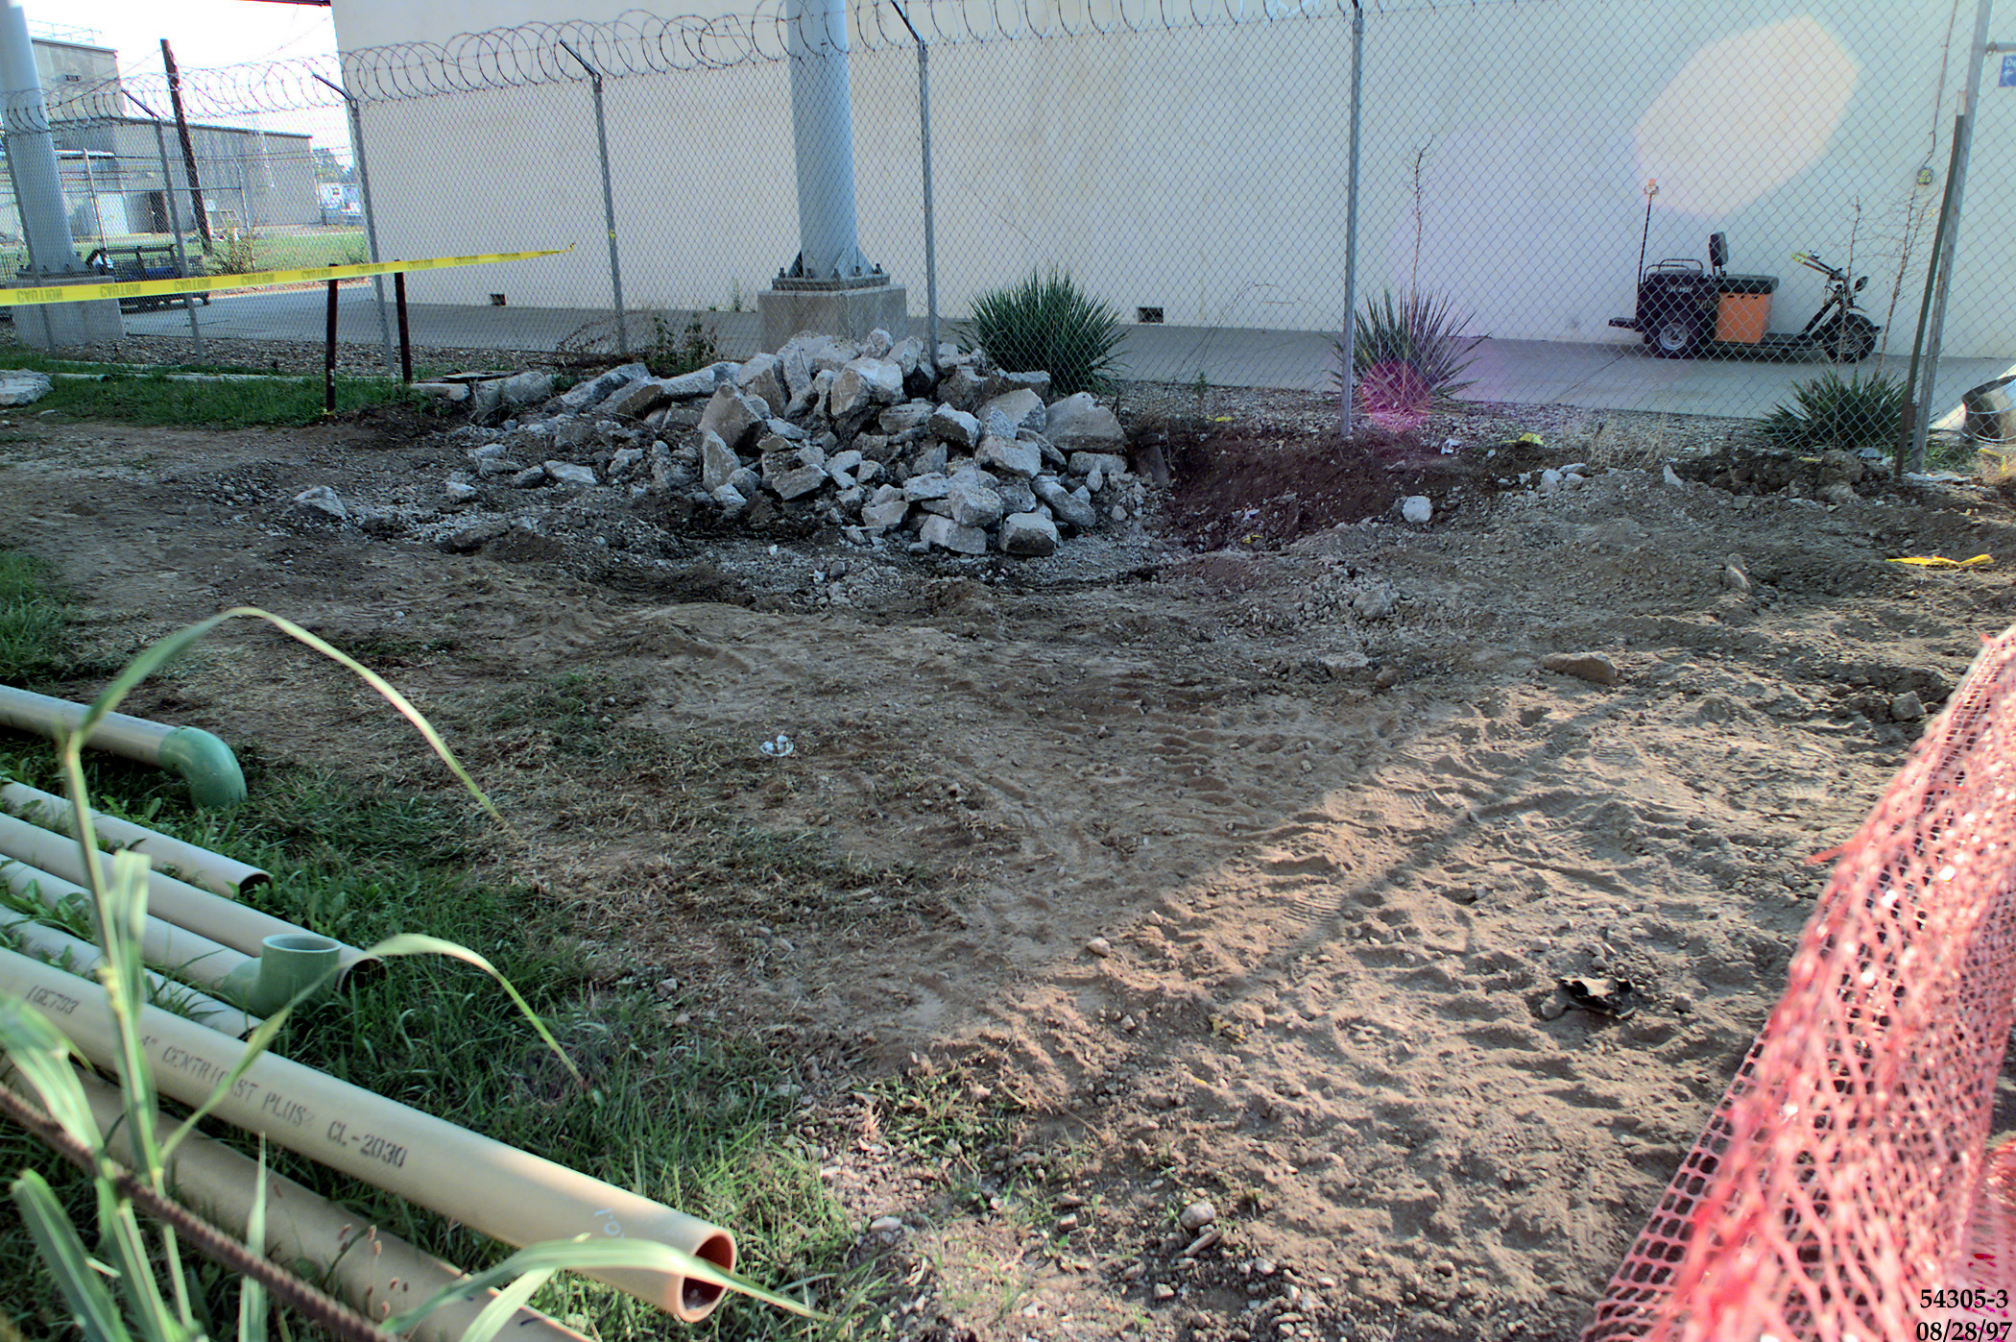
54305-3

This photograph was taken facing northeast, looking toward the North Slab Removal Area after the slab was broken up. The surface sump is still intact in the upper left corner by the rubble pile.

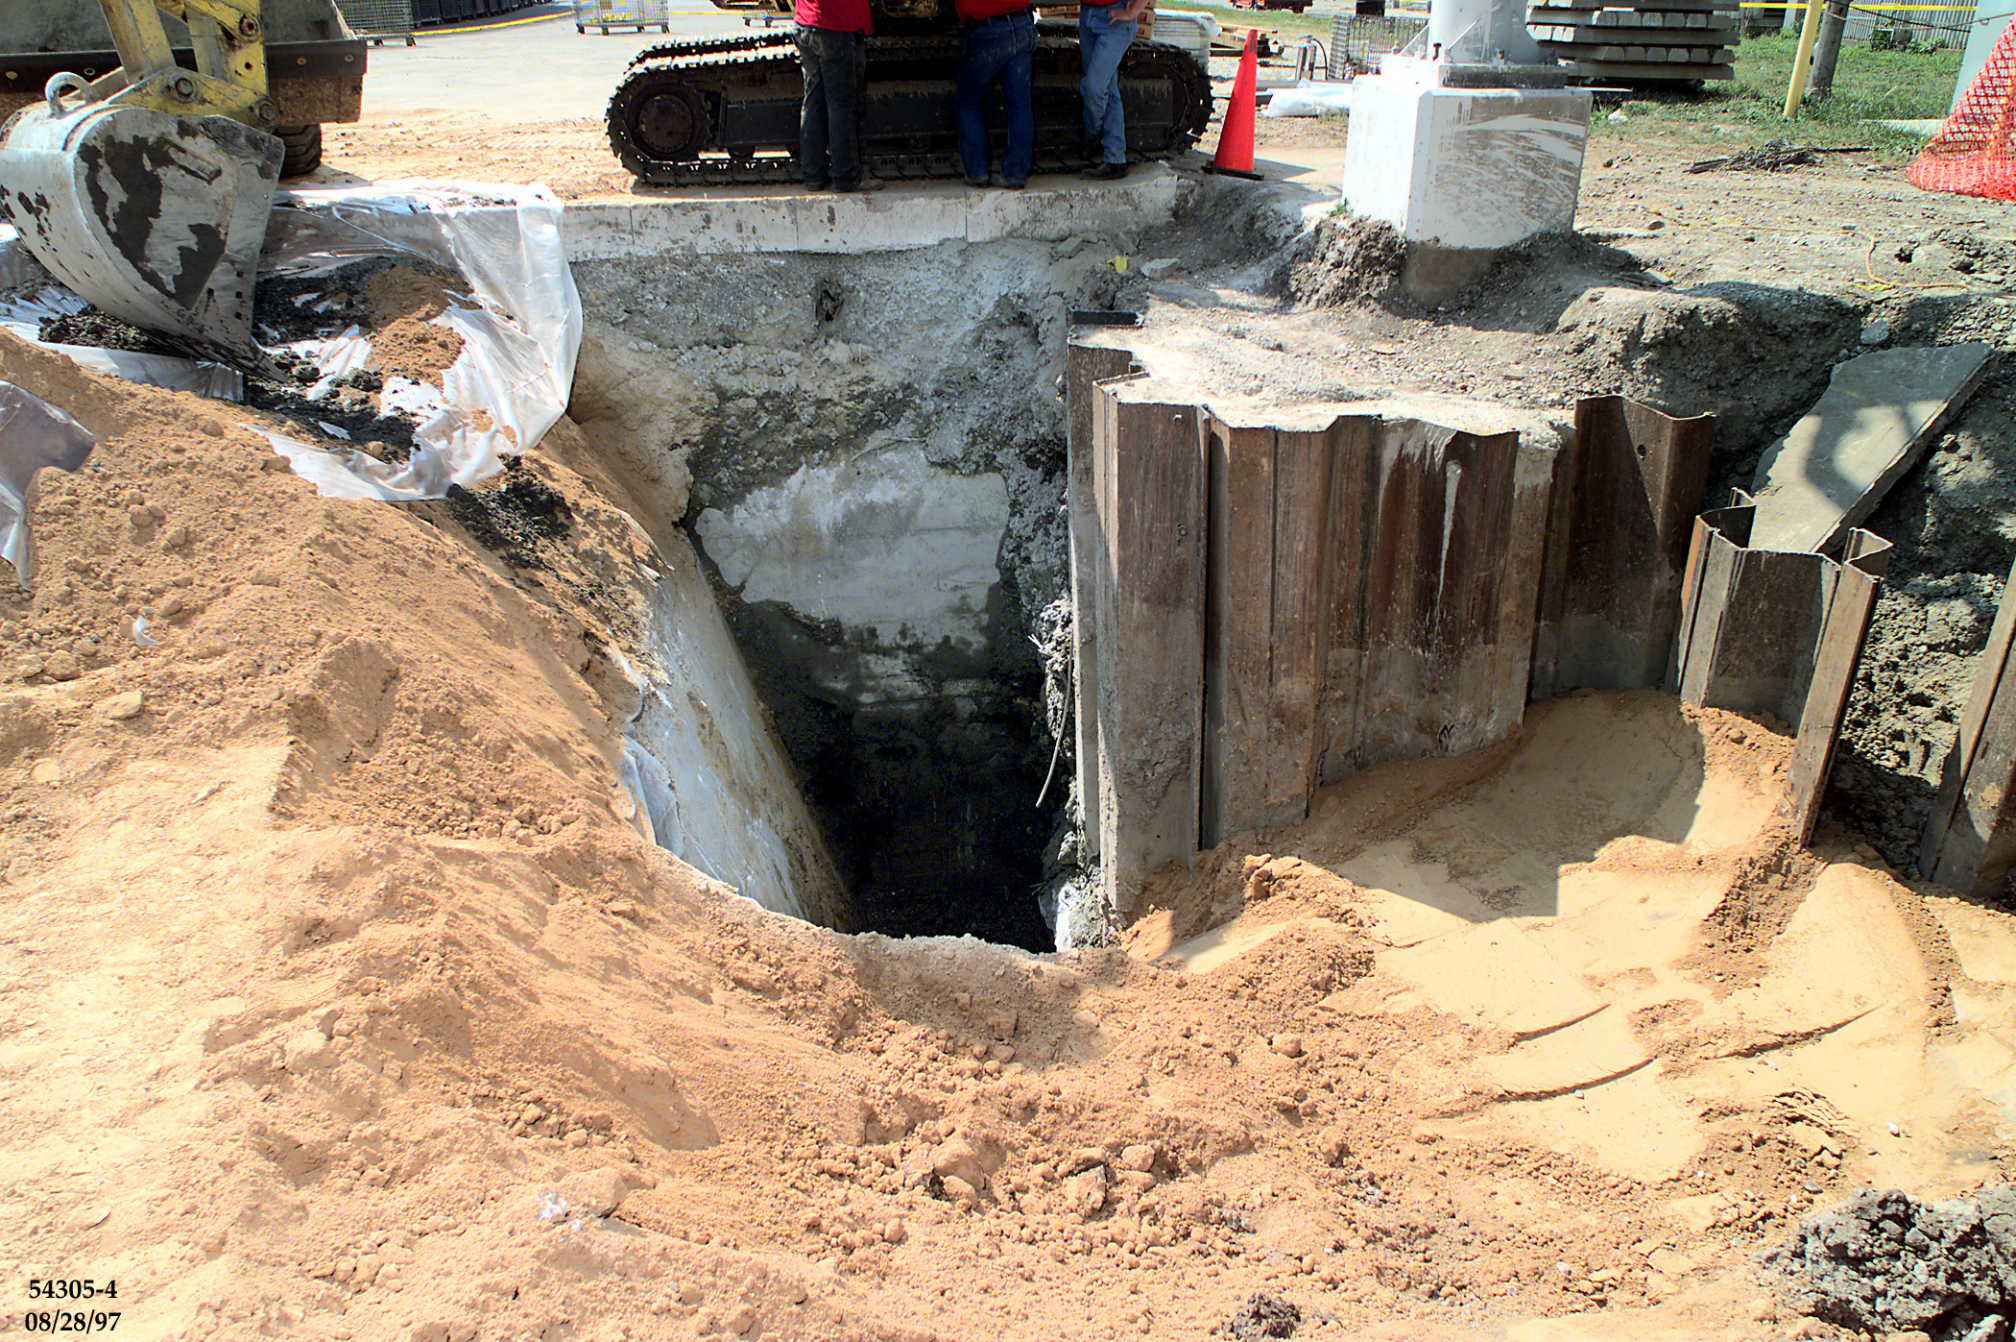
54305-4
08/28/97

This photograph was taken facing west, looking down into Zones A & B while backfilling was in progress.

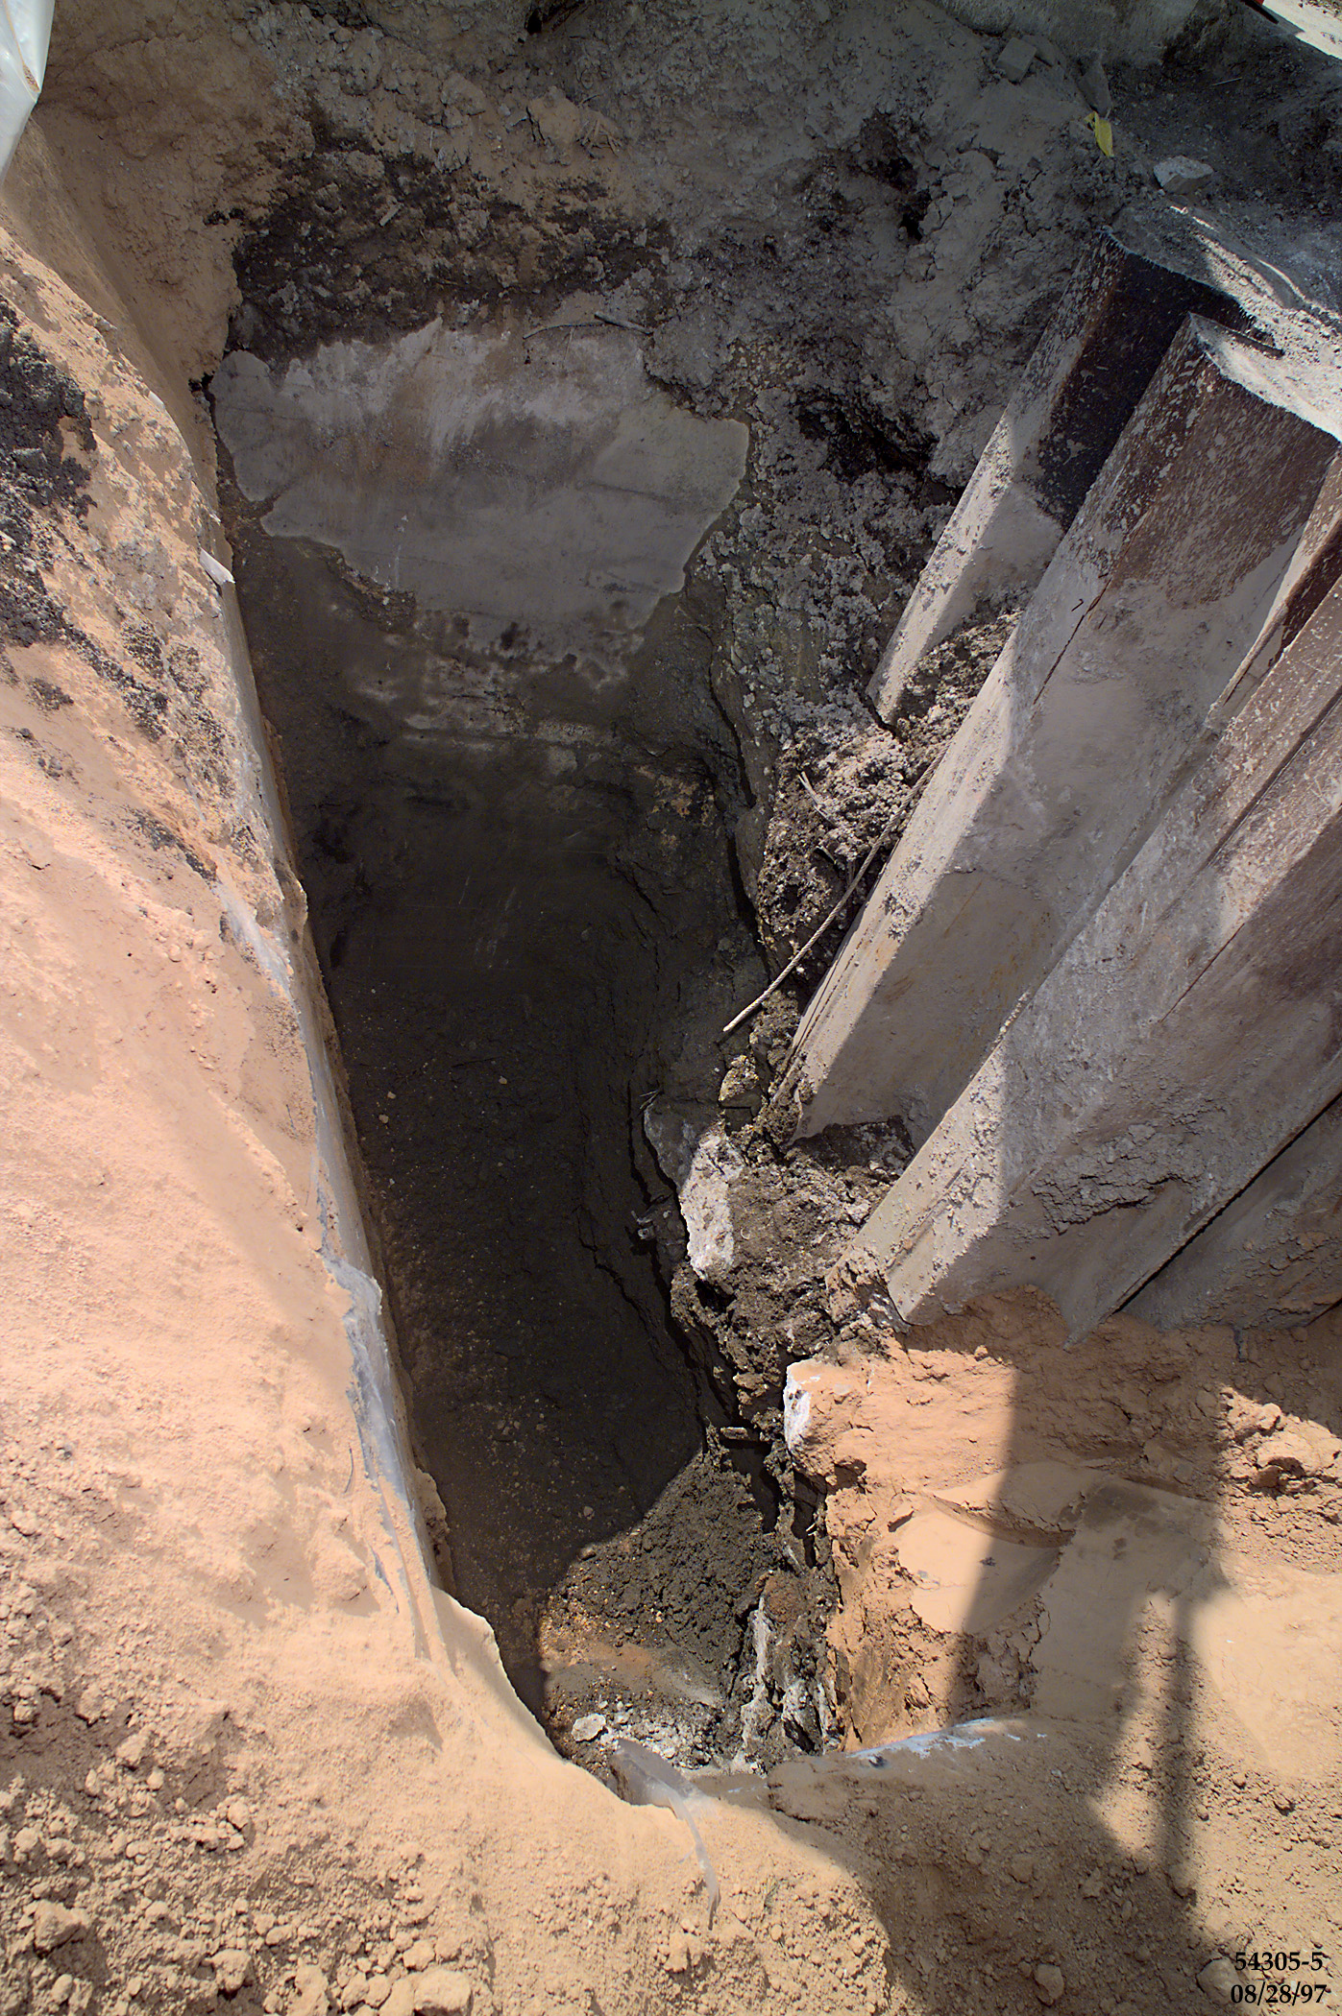
Photograph #54305-5, 08/28/97

This photograph was taken facing west, looking down into Zone B (number stamp in lower right corner). This photo shows the sheet piling that was installed to protect the Twr 10 footing. Rubble beneath the sheet piles (that was left in place) is visible. The depth of the Zone B excavation was limited to 15 feet to prevent undermining the Twr 10 footing.

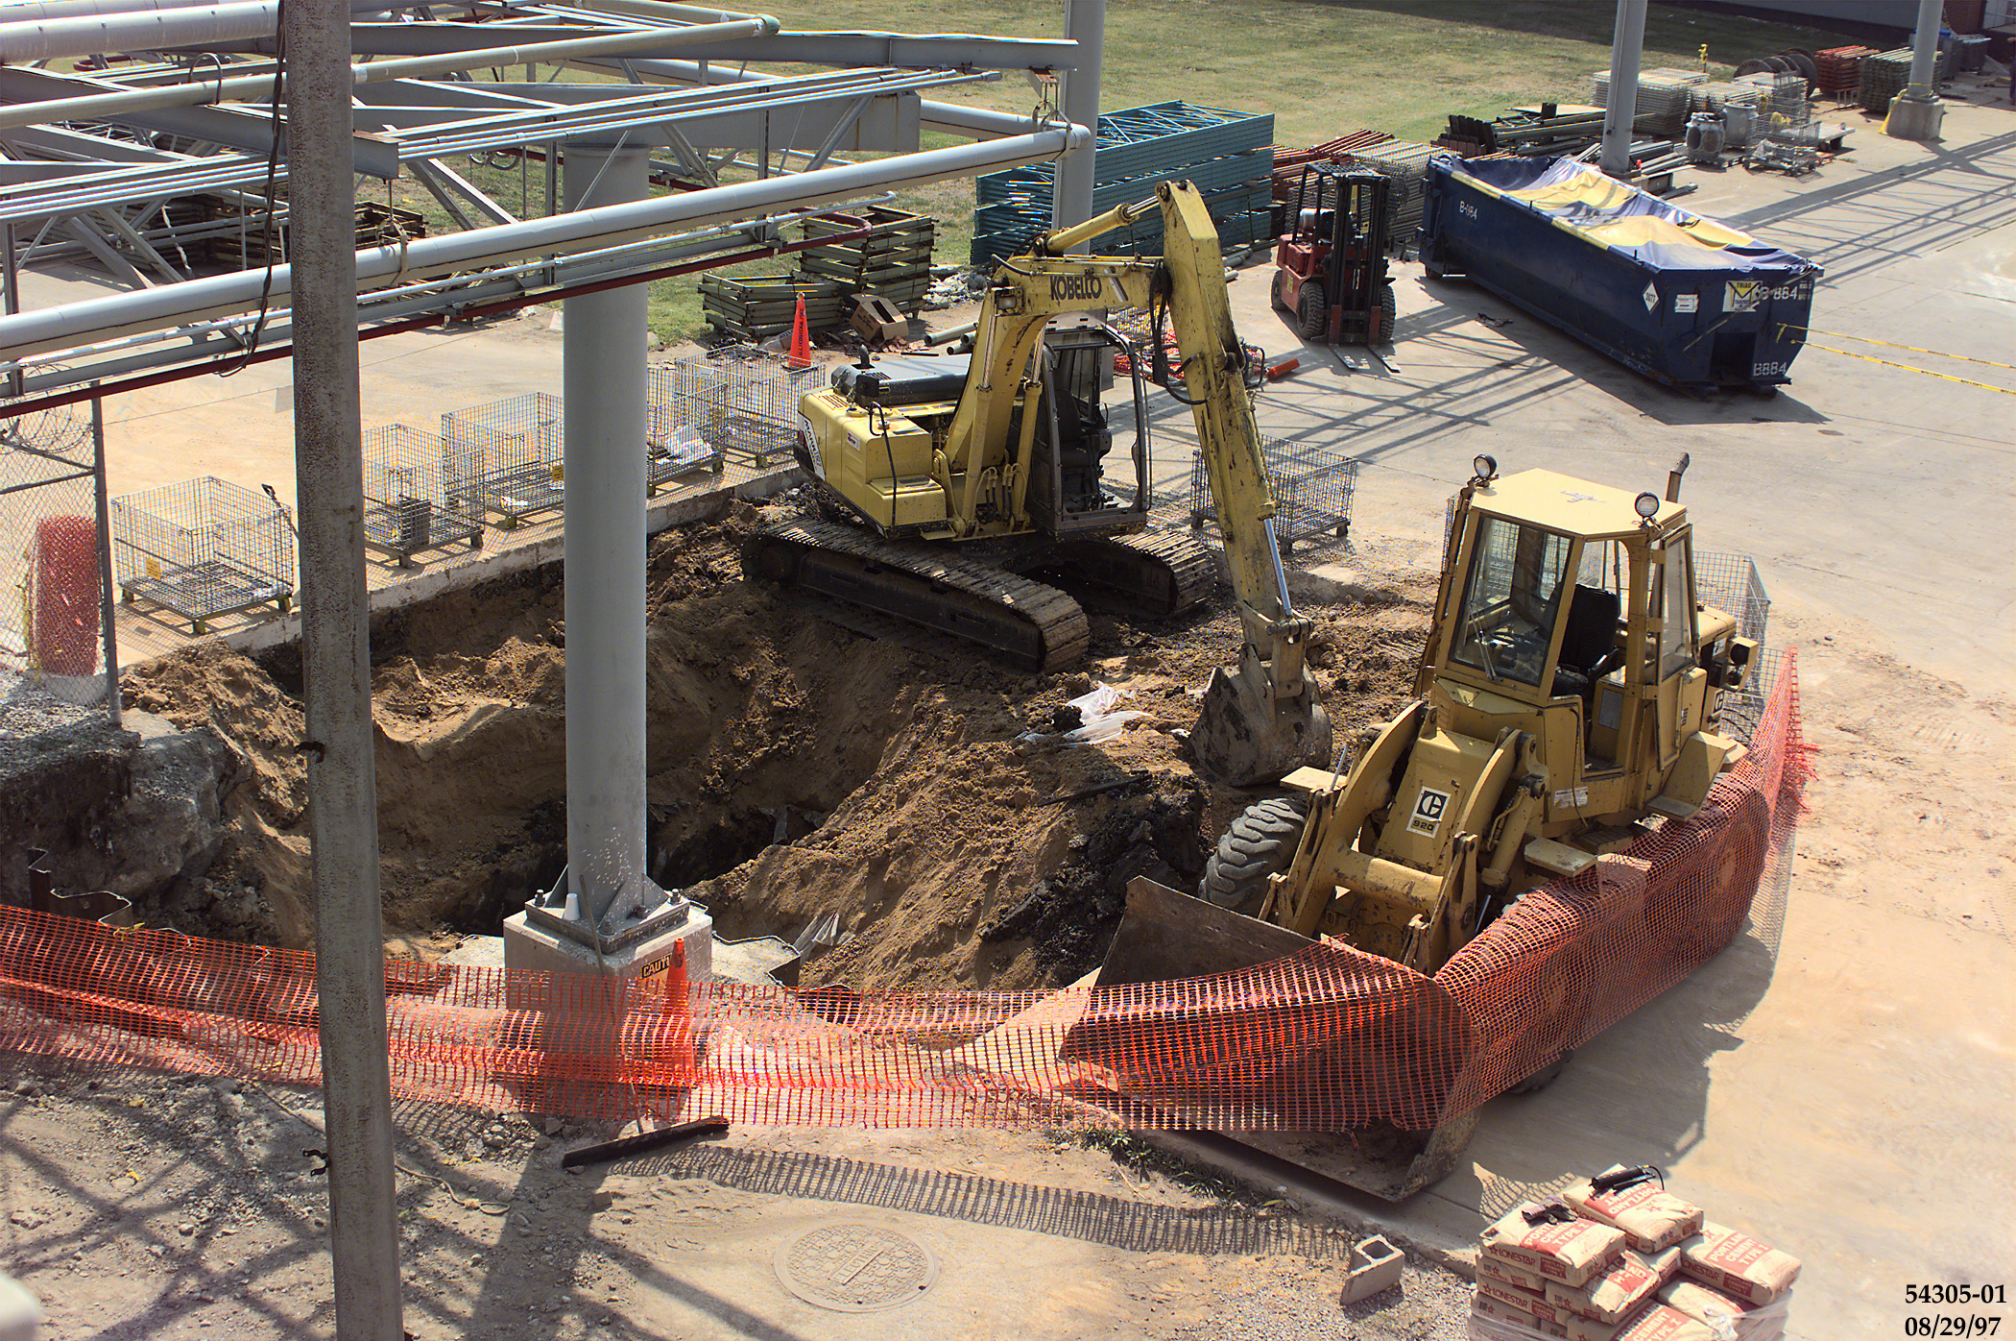
Photograph #54305-01, 08/29/97

This photograph was taken facing southeast, looking down from an elevated platform on a nearby water tank. A typical hazardous waste container used is shown in the upper right corner of the picture.

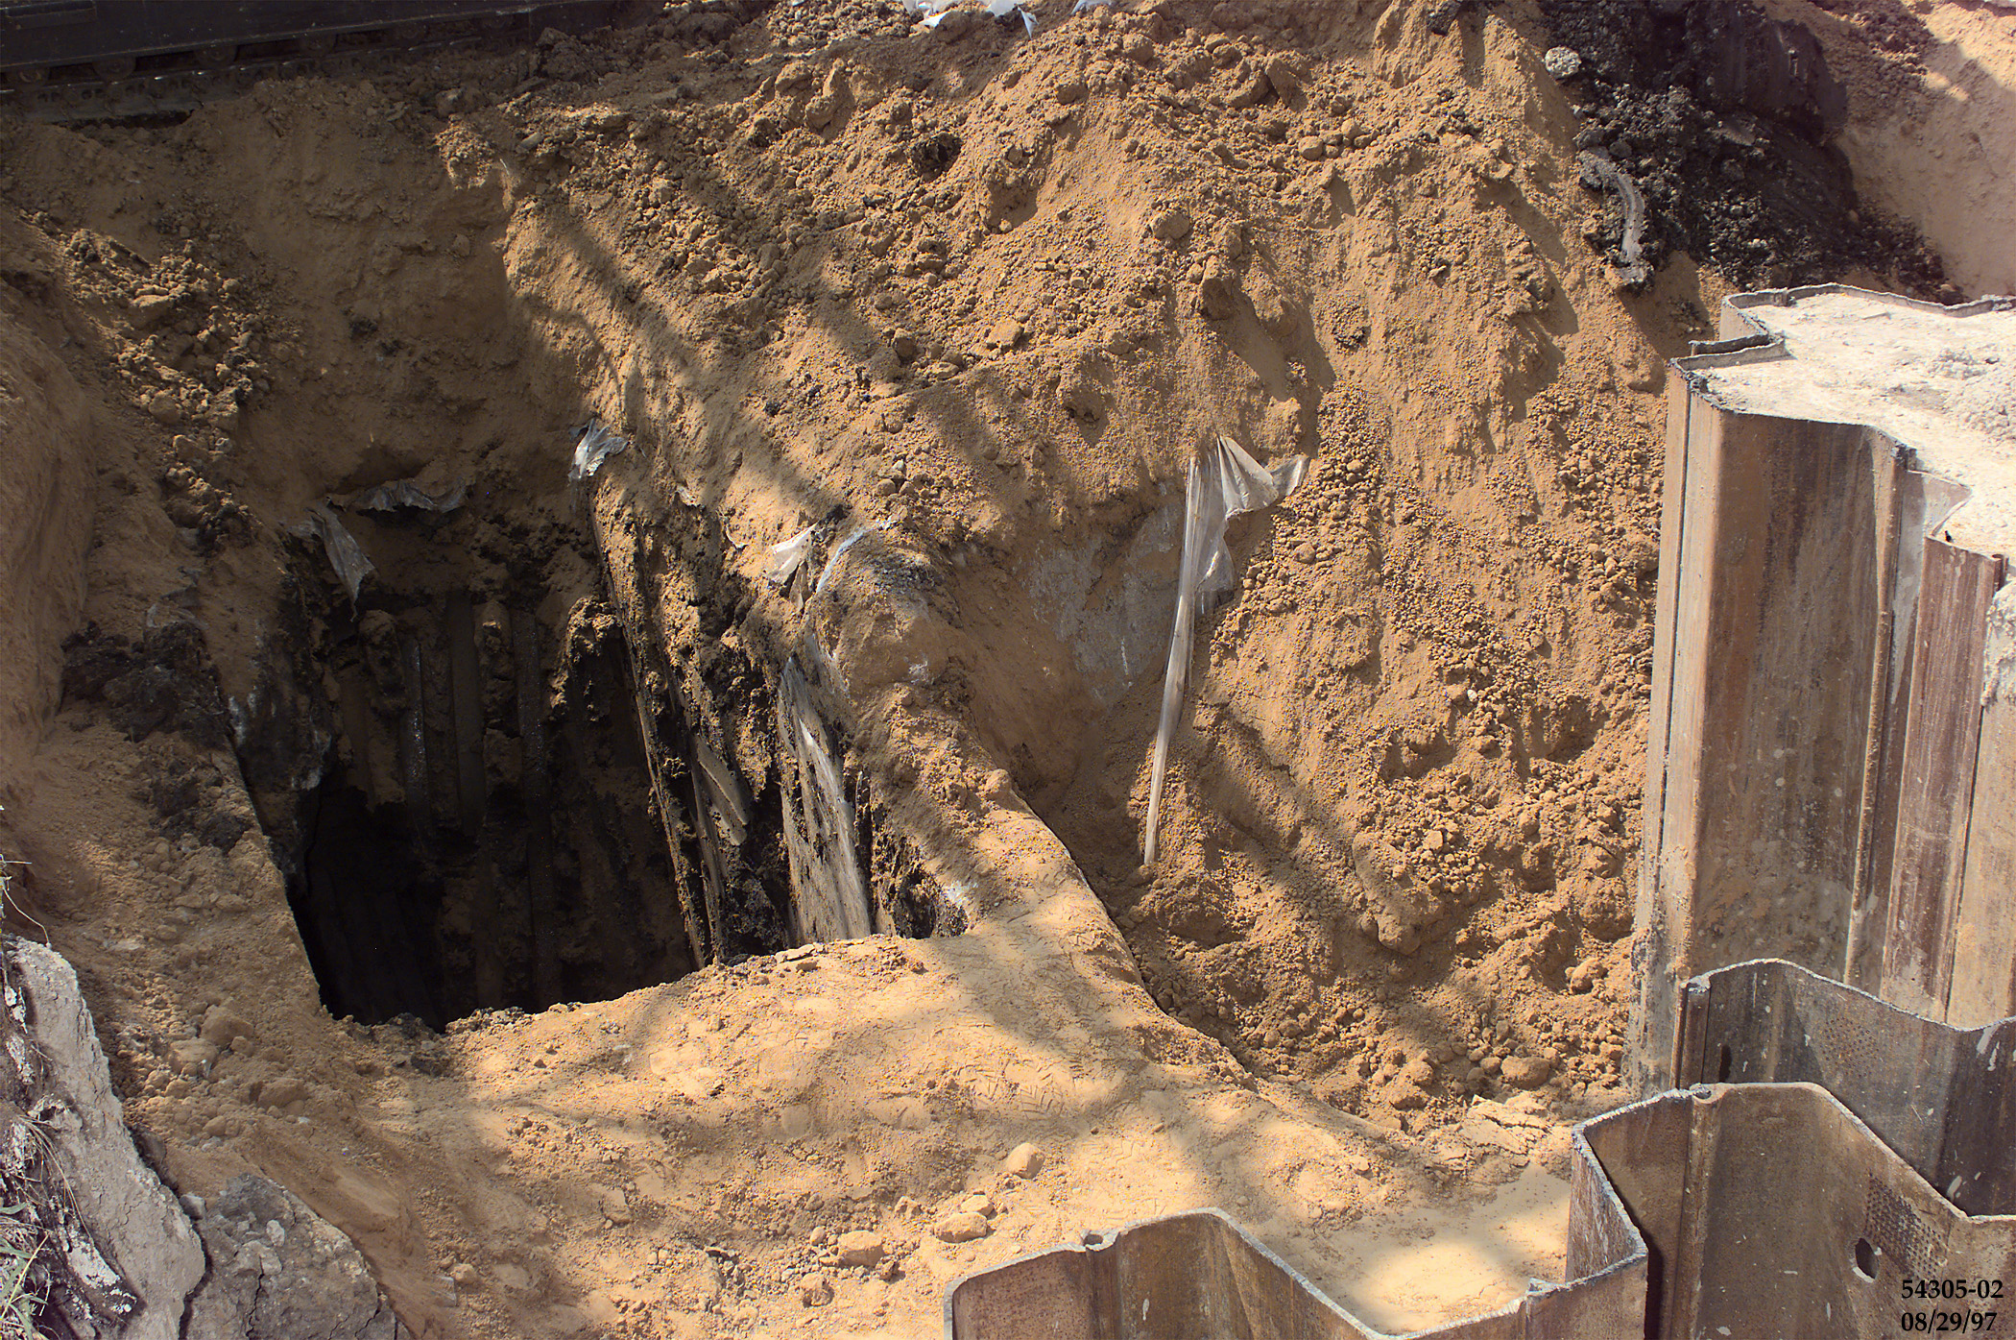
54305-02
08/29/97

This photograph was taken facing south, looking over Zones A and B which have been nearly completely backfilled with clean clay. Zone C backfilling has not yet begun.

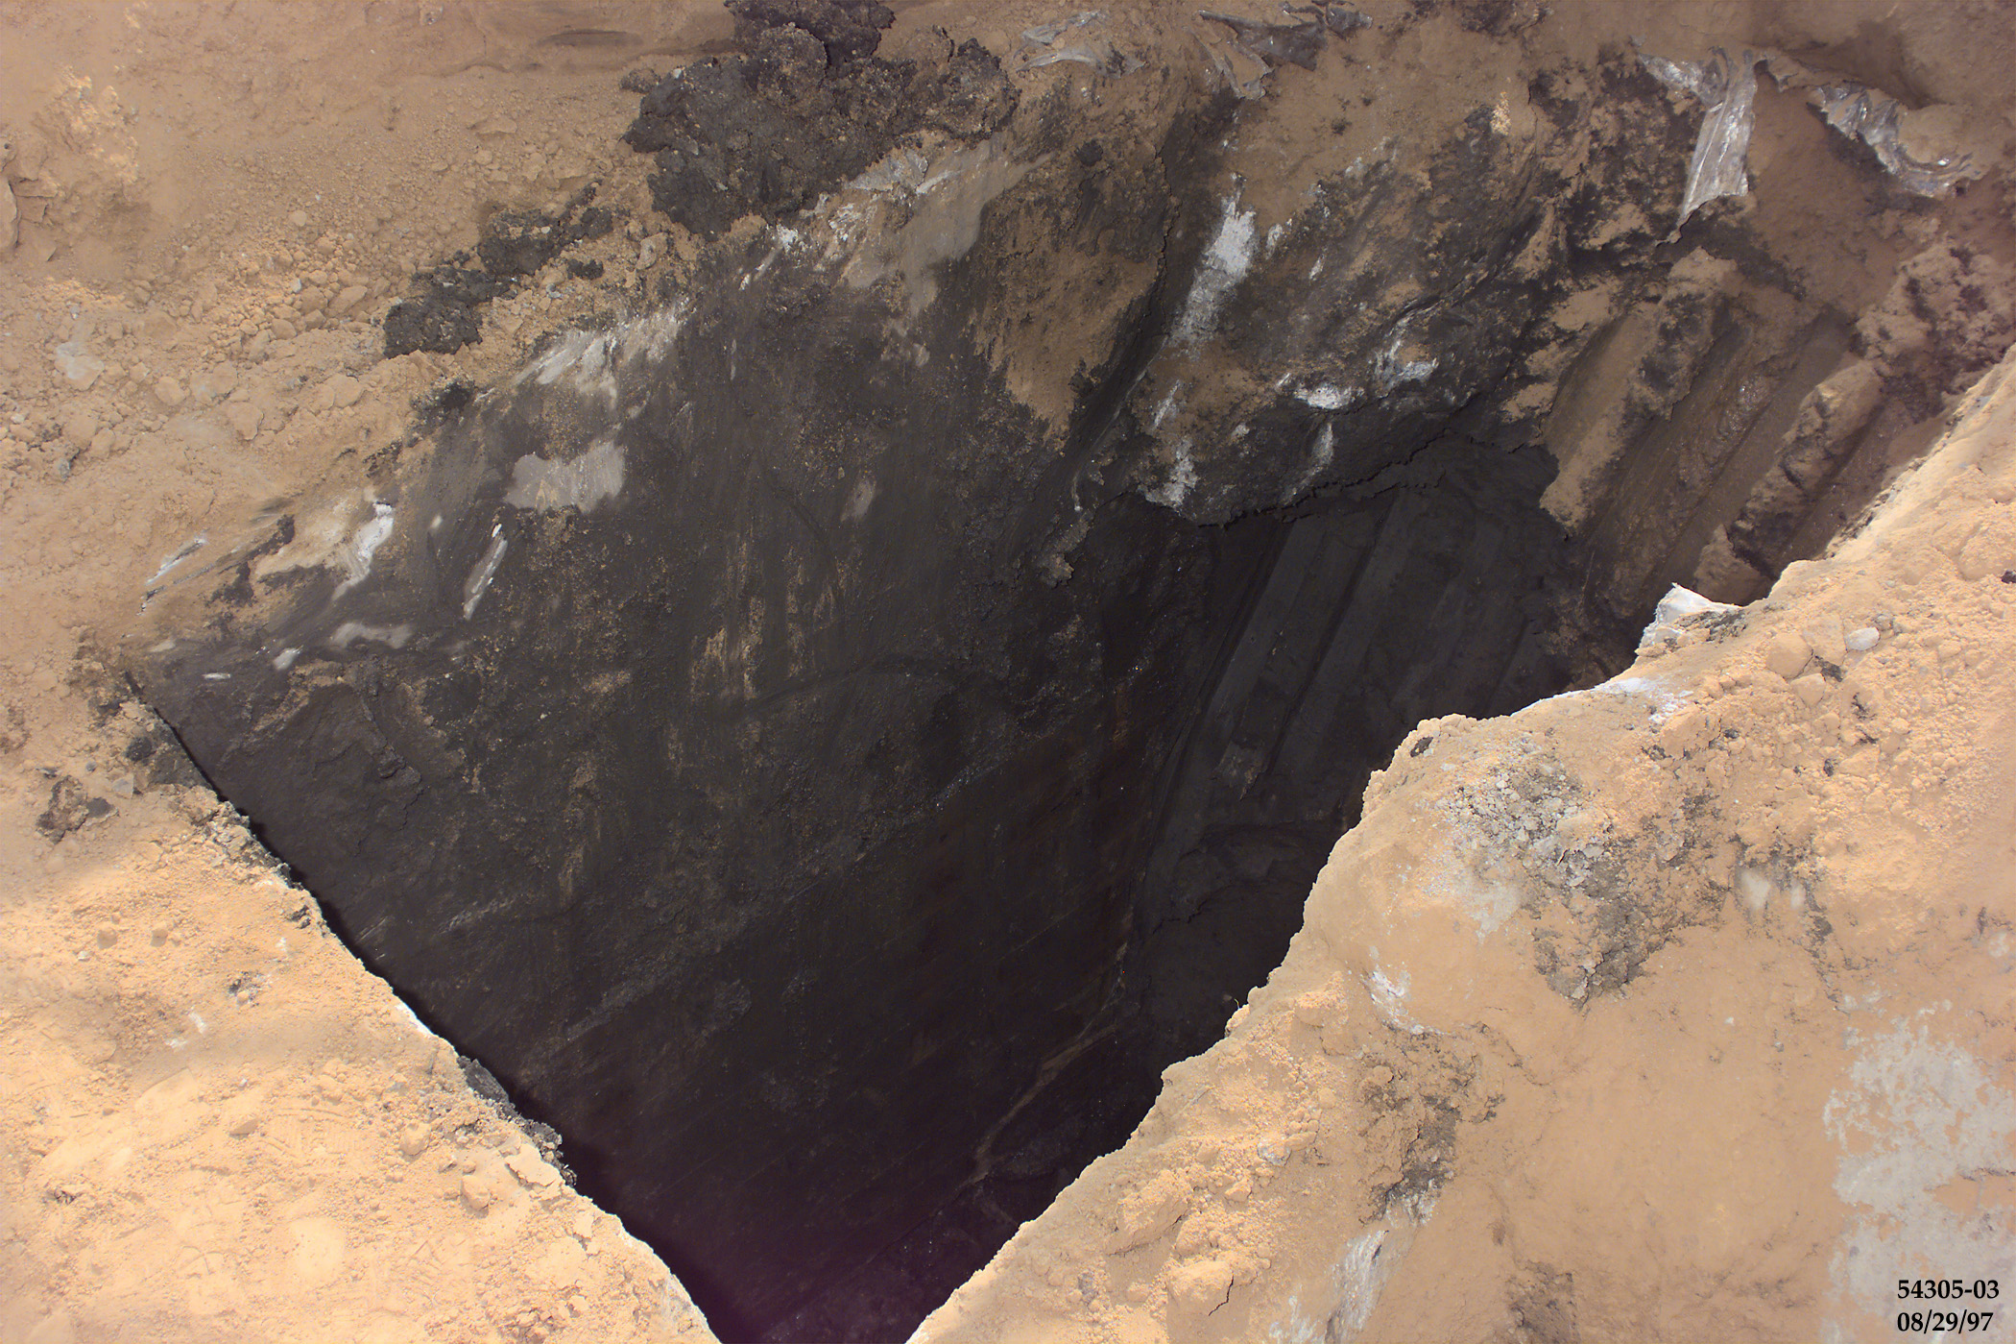
Photograph #54305-03, 08/29/97

This photograph was taken facing southeast, looking over Zones A and B into Zone C before backfilling for Zone C began. Notice the thickened concrete wall toward the upper right corner of the photo. This wall thickening is shown on Figure 4B.

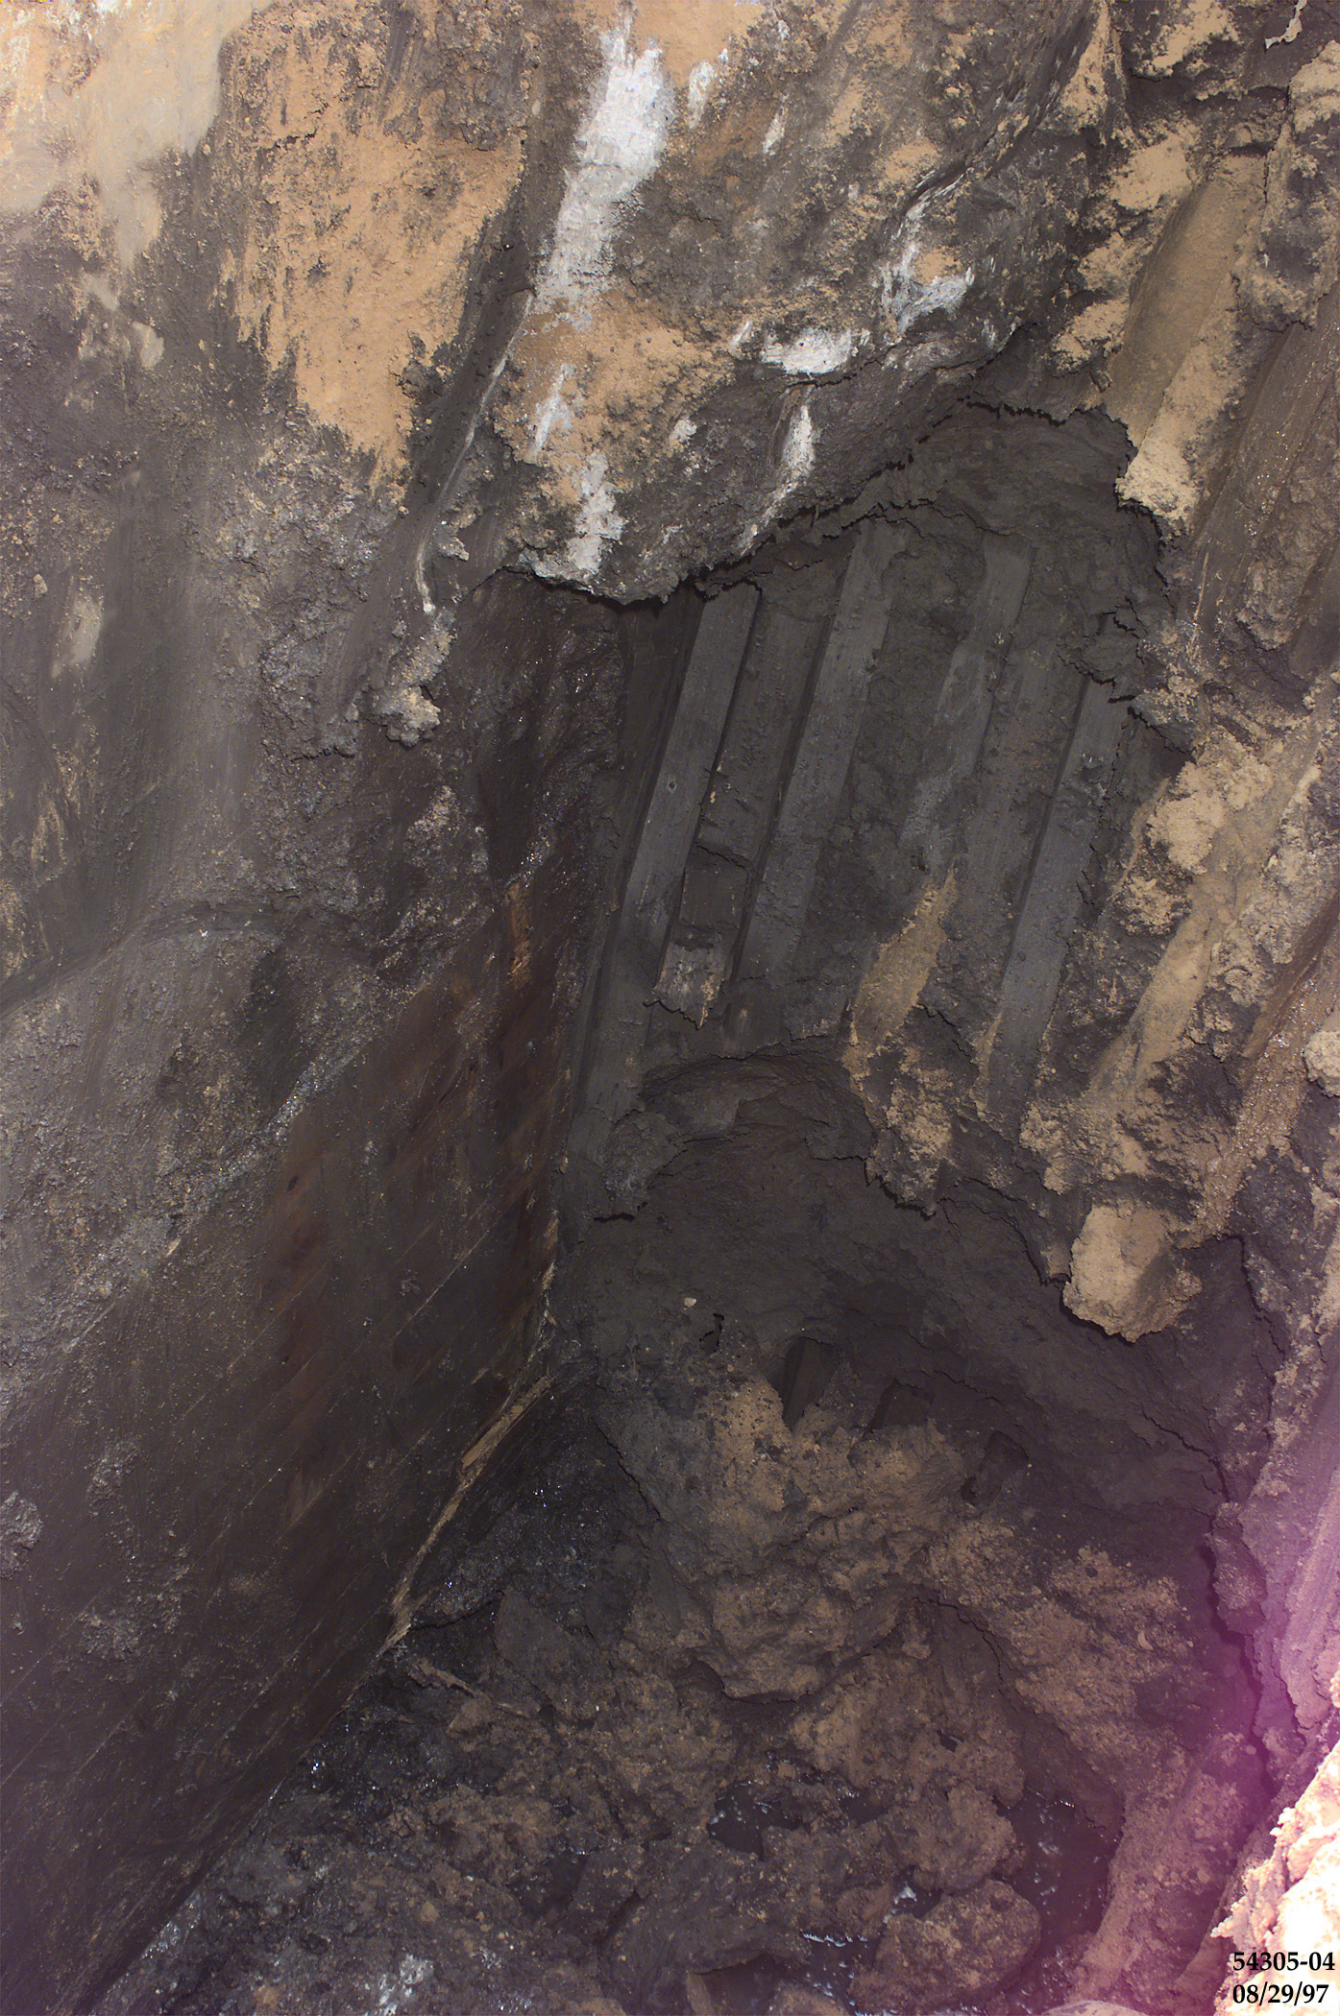
Photograph #54305-04, 08/29/97

This photograph was taken facing southeast (number stamp in the lower right corner), looking into Zone C before backfilling for Zone C began. Notice the thickened concrete wall toward the upper center of the photo. This wall thickening is shown on Figure 4B. Wood concrete form sheeting is also visible in the lower left side of the picture. The floor slab in the bottom of Zone C is shown in the lower left corner. This floor concrete is about 20 feet below ground surface.
