Section 5 Attachment
Abandoned Sump Photo Chronology

2.9 PHOTOGRAPHIC CHRONOLOGY

The following photographs document construction completed by the subject Interim Measures Construction Project. The descriptive text below is identified with the corresponding photograph number and date (**imprinted in the lower right corner of each photo, unless indicated otherwise**).

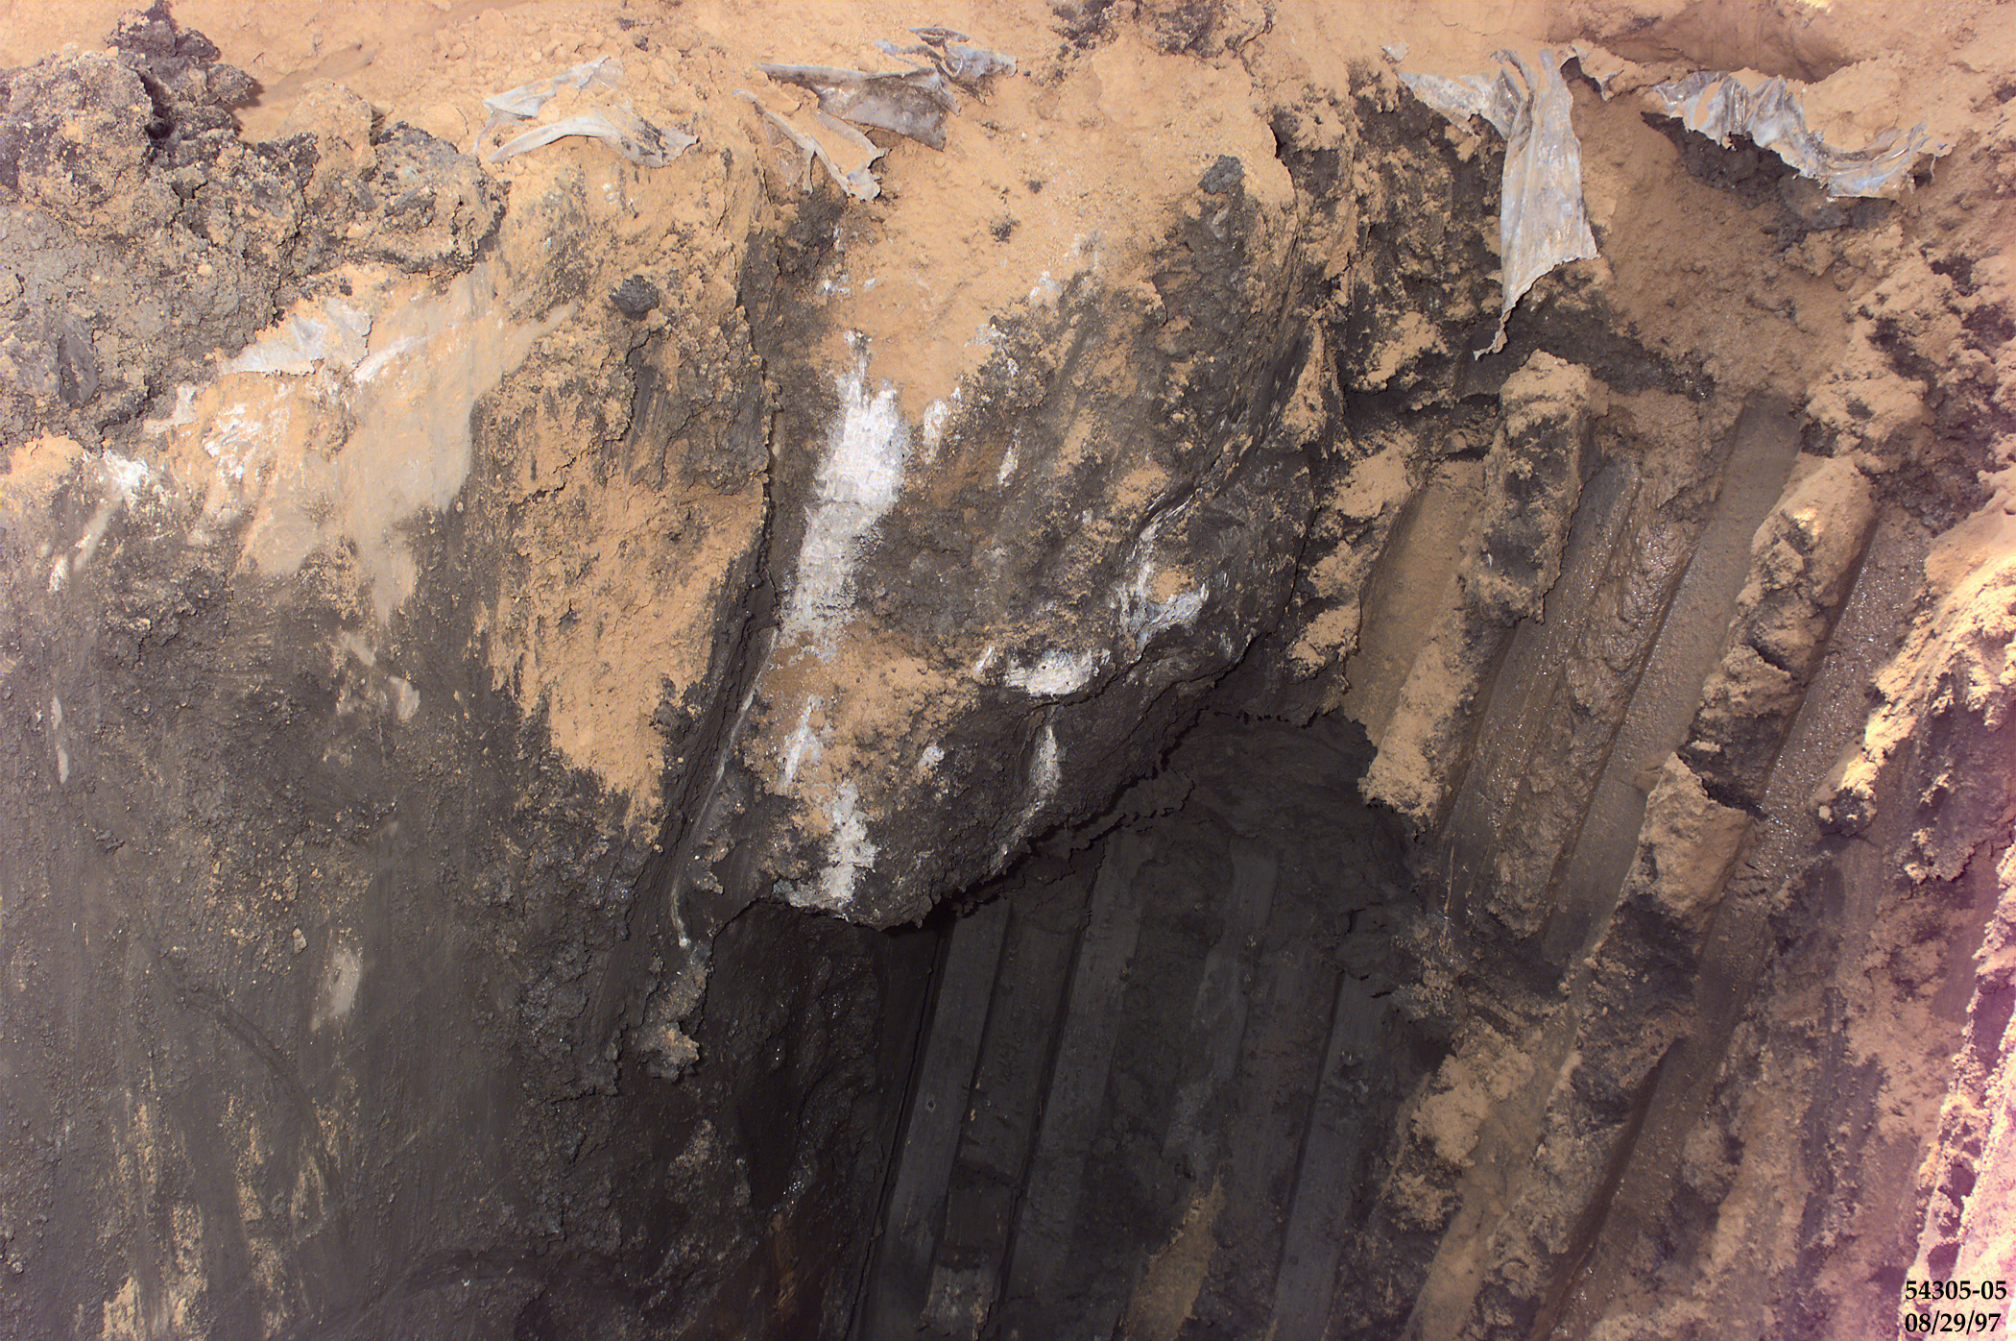
Photograph #54305-05, 08/29/97

This photograph was taken facing southeast (number stamp in the lower right corner), looking down into Zone C before backfilling for Zone C began. Notice the thickened concrete wall toward the upper center of the photo. This wall thickening is shown on Figure 4B.

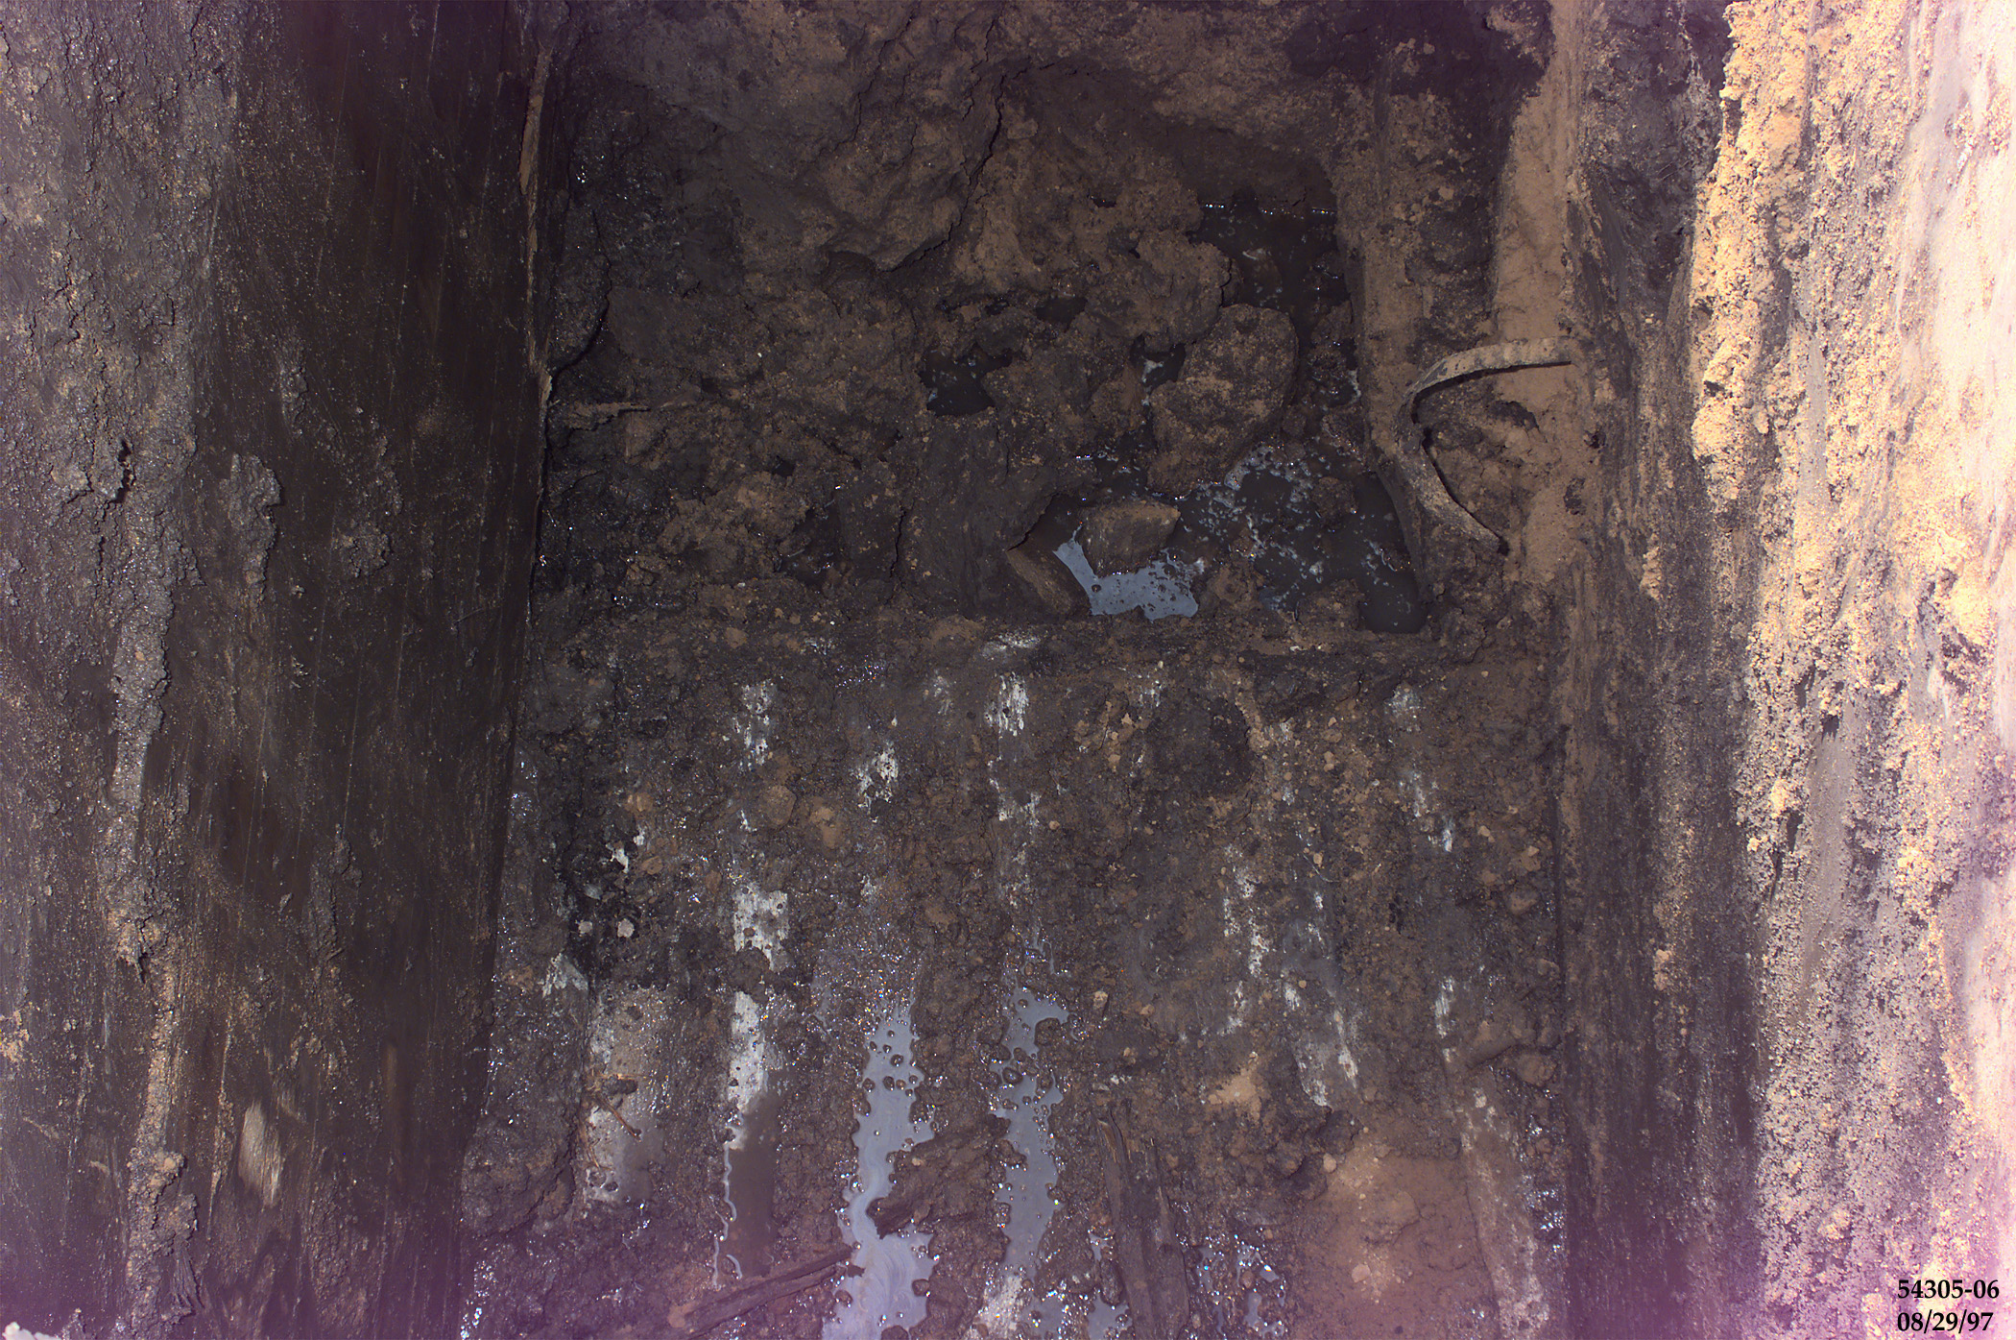
54305-06
08/29/97

This photograph was taken facing south, looking down into Zone C before backfilling for Zone C began. The edge of the floor slab in the bottom of Zone C is shown in the center of the picture. This floor concrete is about 20 feet below ground surface. The vertical wall on the right of the photo is the east boundary of Zone B.

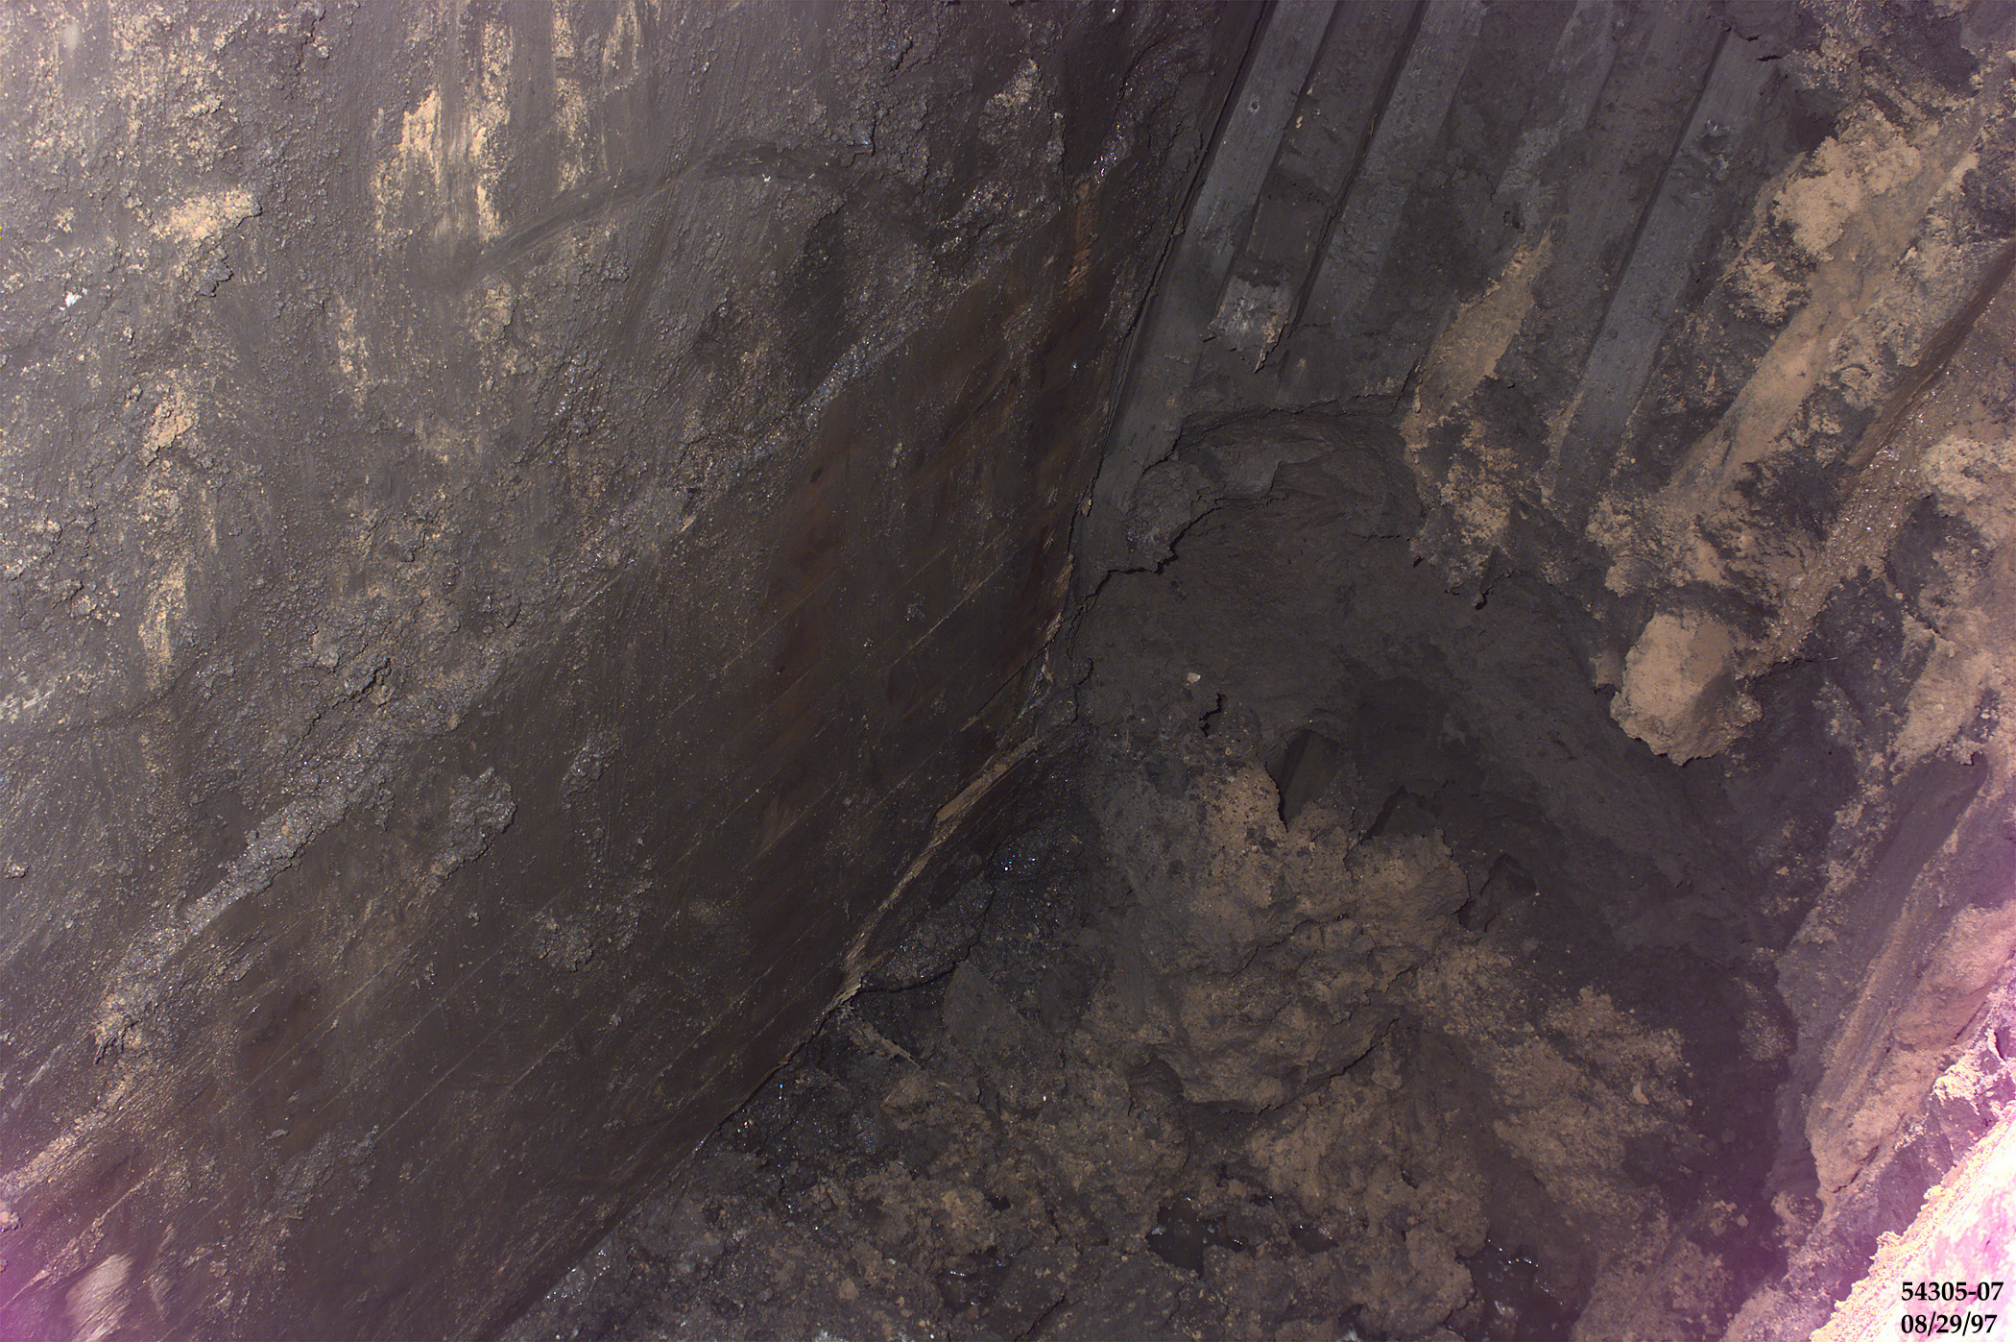
54305-07
08/29/97

This photograph was taken facing southeast, looking down into Zone C before backfilling for Zone C began.

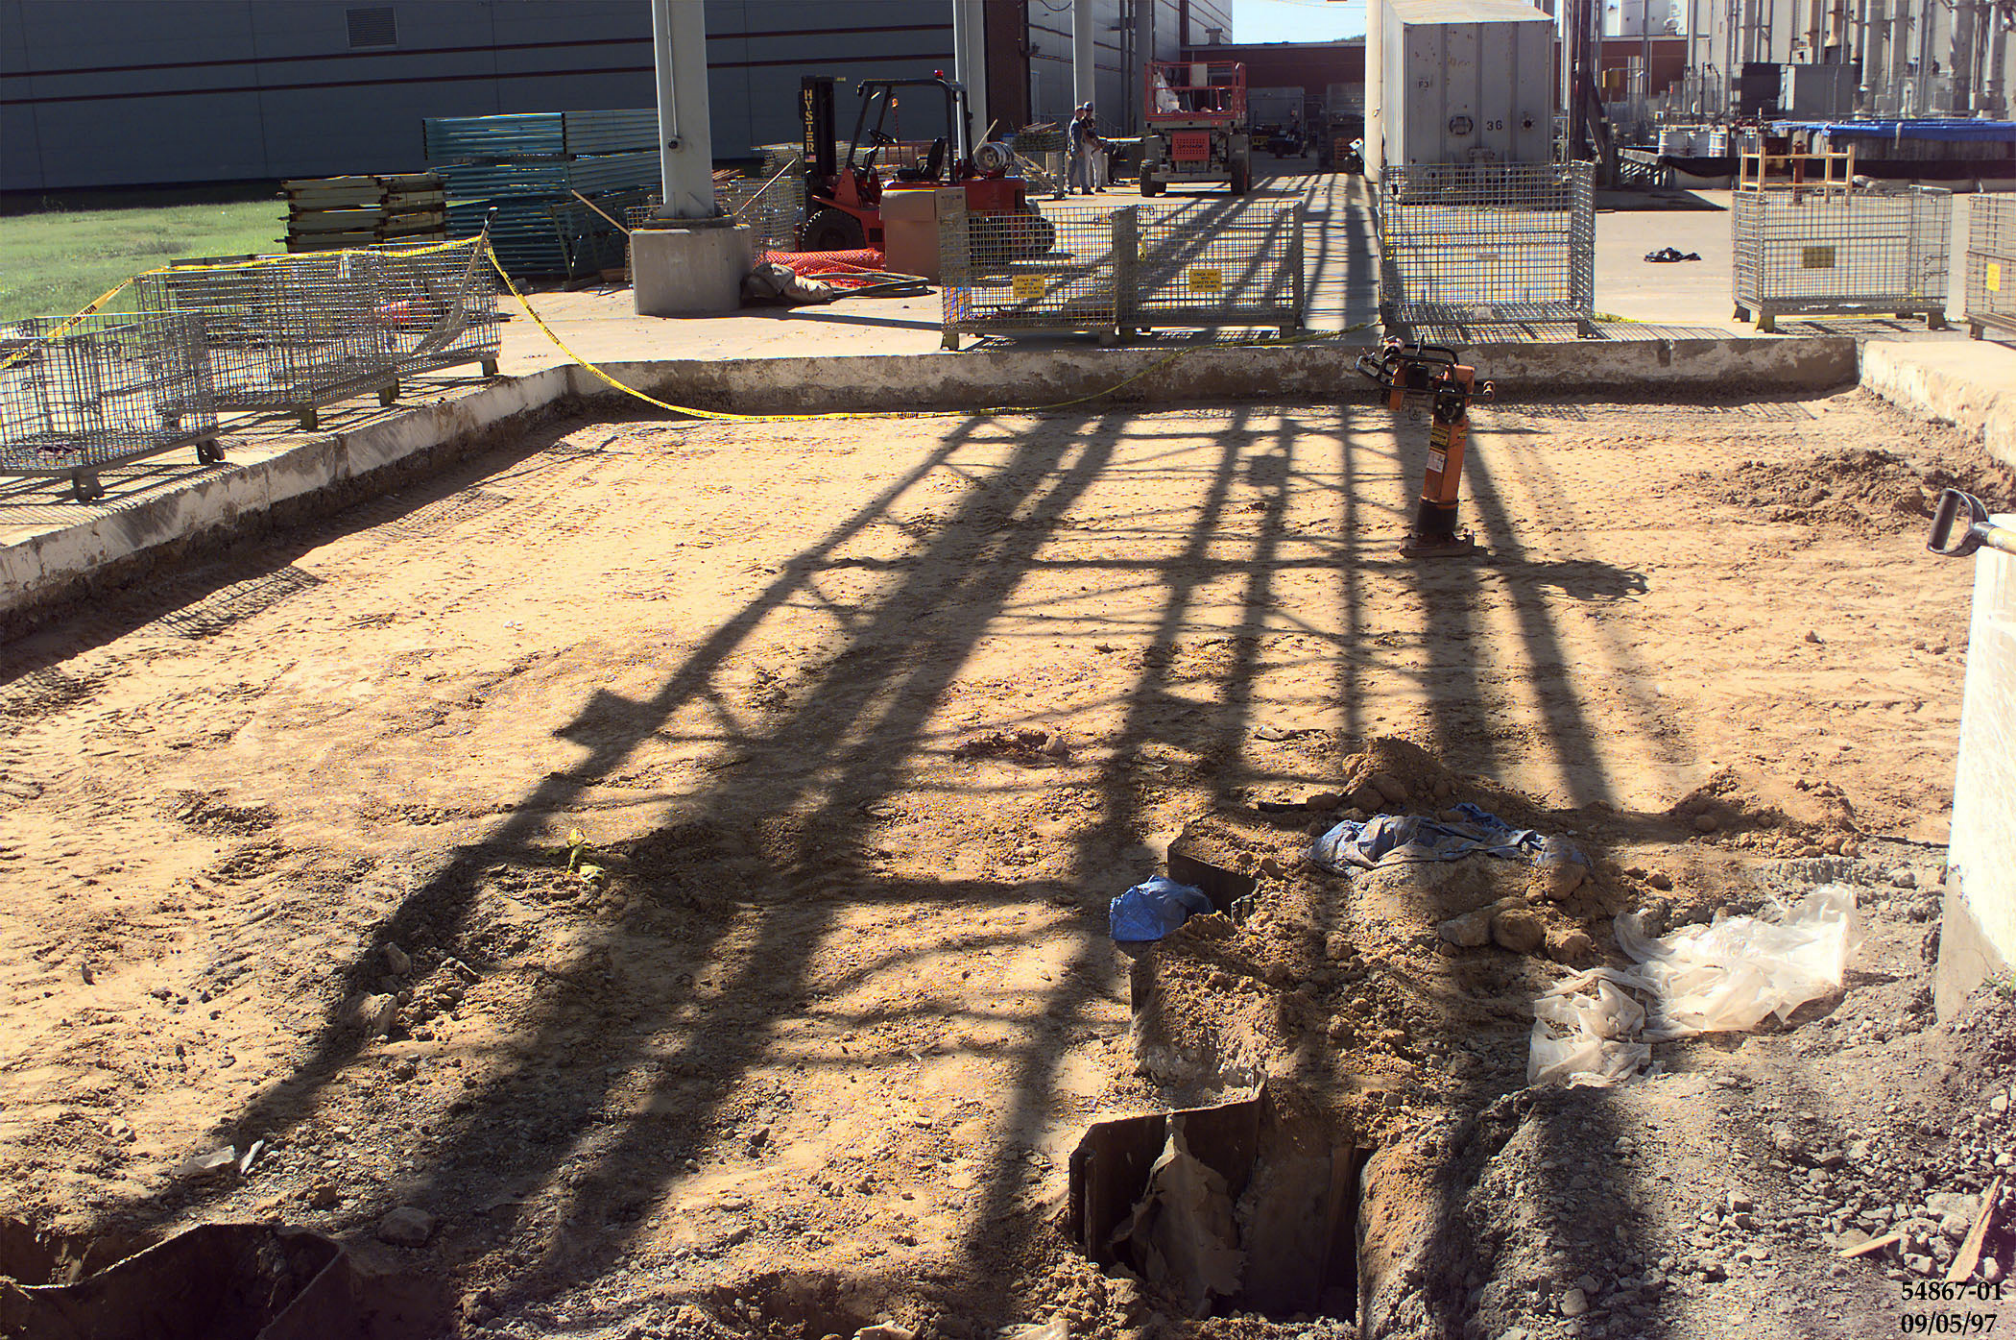
54867-01
09/05/97

This photograph was taken facing south, looking over South excavation area after clay compaction was completed.

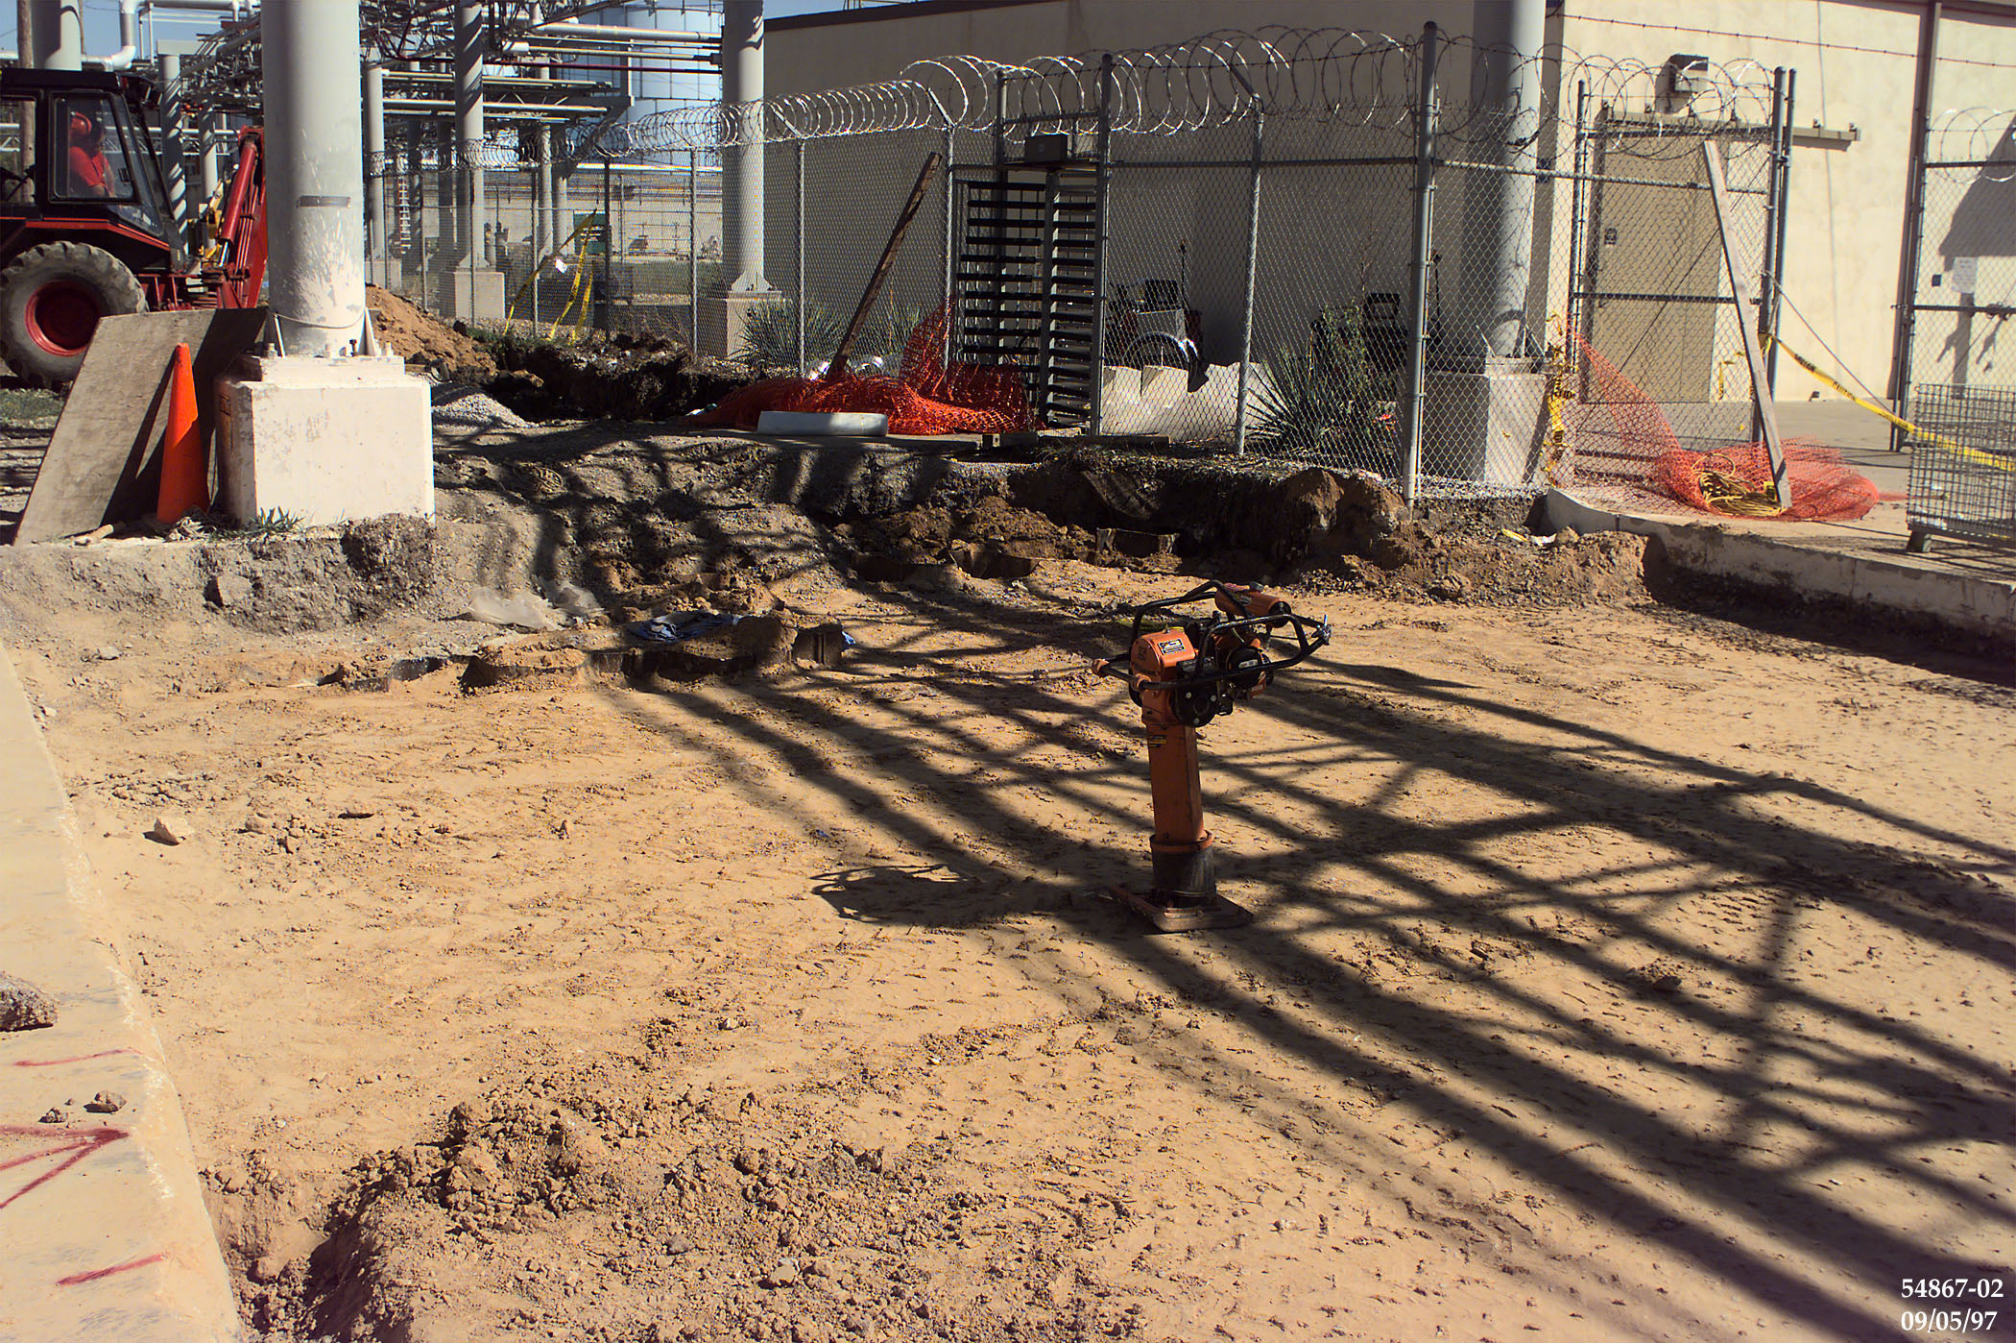
Photograph #54867-02, 09/05/97

This photograph was taken facing northeast, looking over South excavation area after clay compaction was completed.

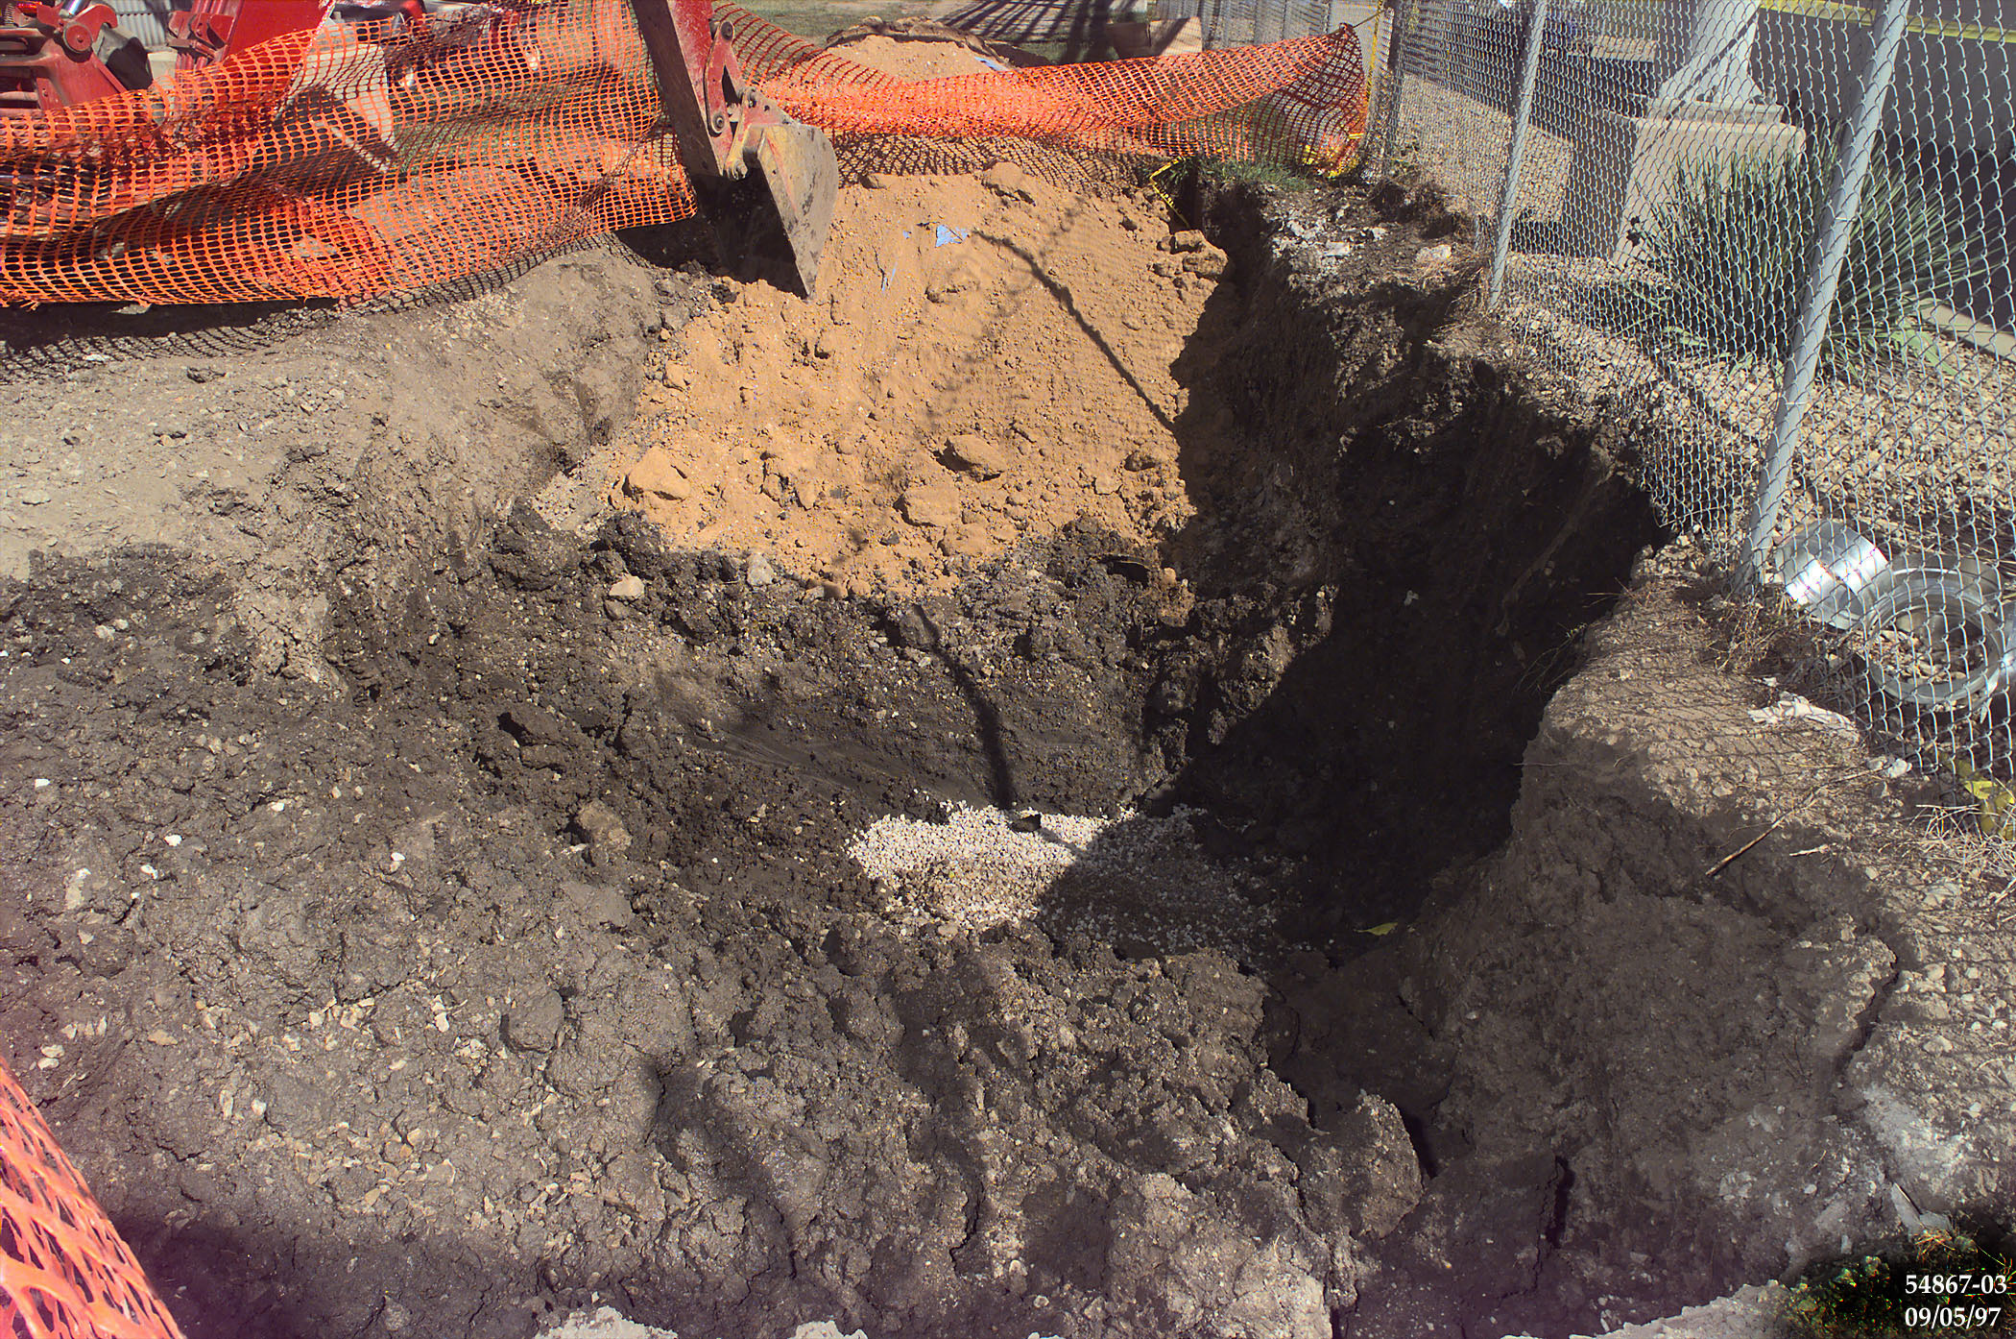
Photograph #54867-03, 09/05/97

This photograph was taken facing northeast, looking over North Slab Removal Area excavation. Backfilling has begun on the north end of the site. The white gravel in the center was placed around a damaged watermain valve box that had to be replaced before backfilling could continue.

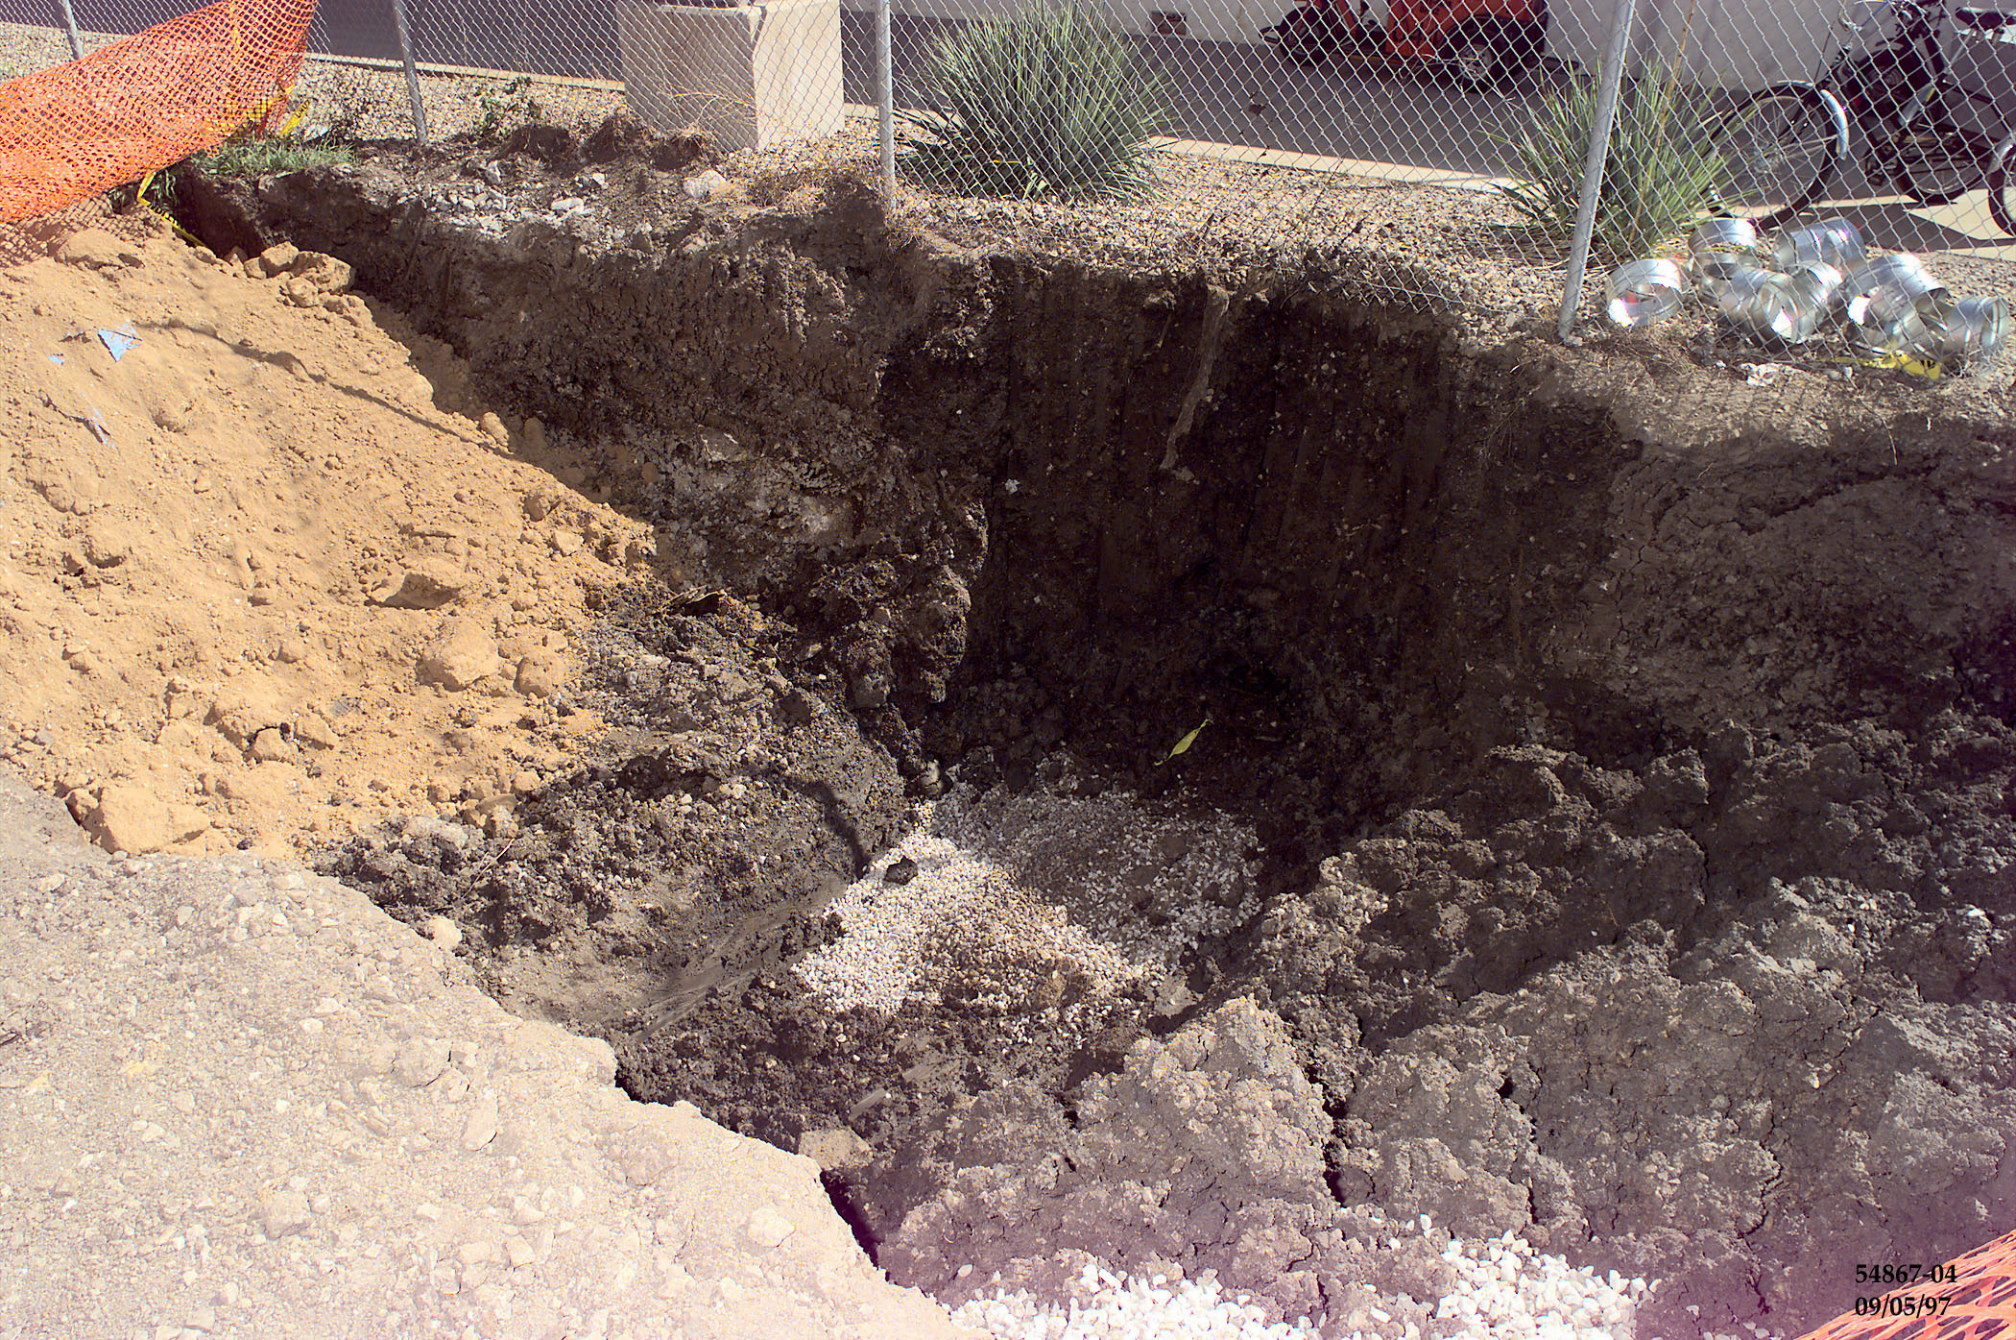
54867-04
09/05/97

This photograph was taken facing east, looking over North Slab Removal Area excavation. Backfilling has begun on the north end of the site. The white gravel in the center was placed around a damaged watermain valve box that had to be replaced before backfilling could continue.

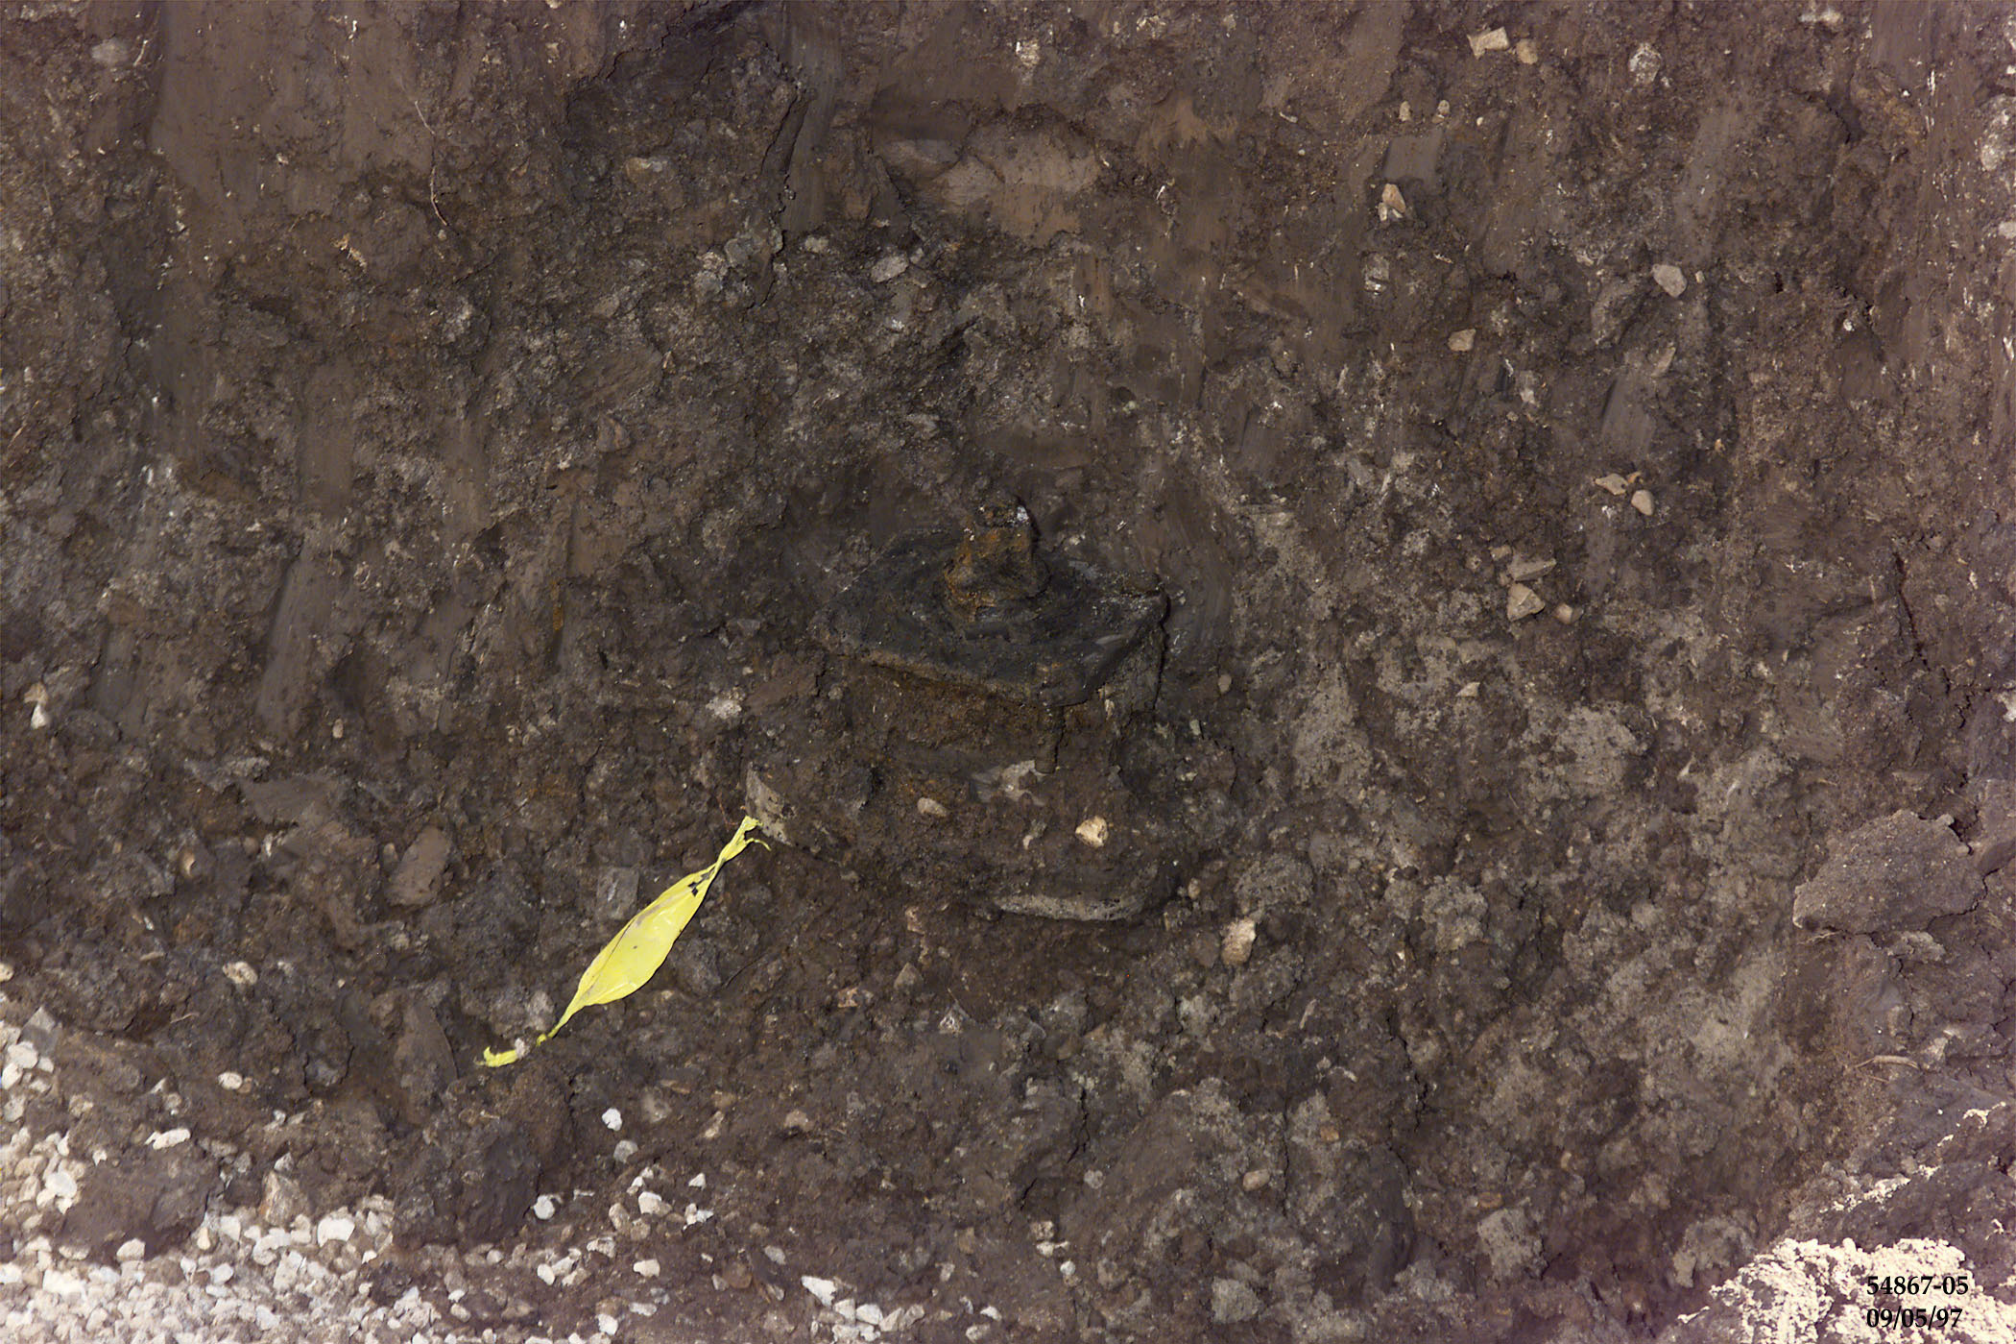
54867-05
09/05/97

Close-up of watermain valvebox bearing plate. Valve box bears on top plate in center of picture. This photograph was taken facing east (number stamp in the lower right corner), looking over North Slab Removal Area excavation.
