Section 5 Attachment
Abandoned Sump Photo Chronology

2.9 PHOTOGRAPHIC CHRONOLOGY

The following photographs document construction completed by the subject Interim Measures Construction Project. The descriptive text below is identified with the corresponding photograph number and date (**imprinted in the lower right corner of each photo, unless indicated otherwise**).

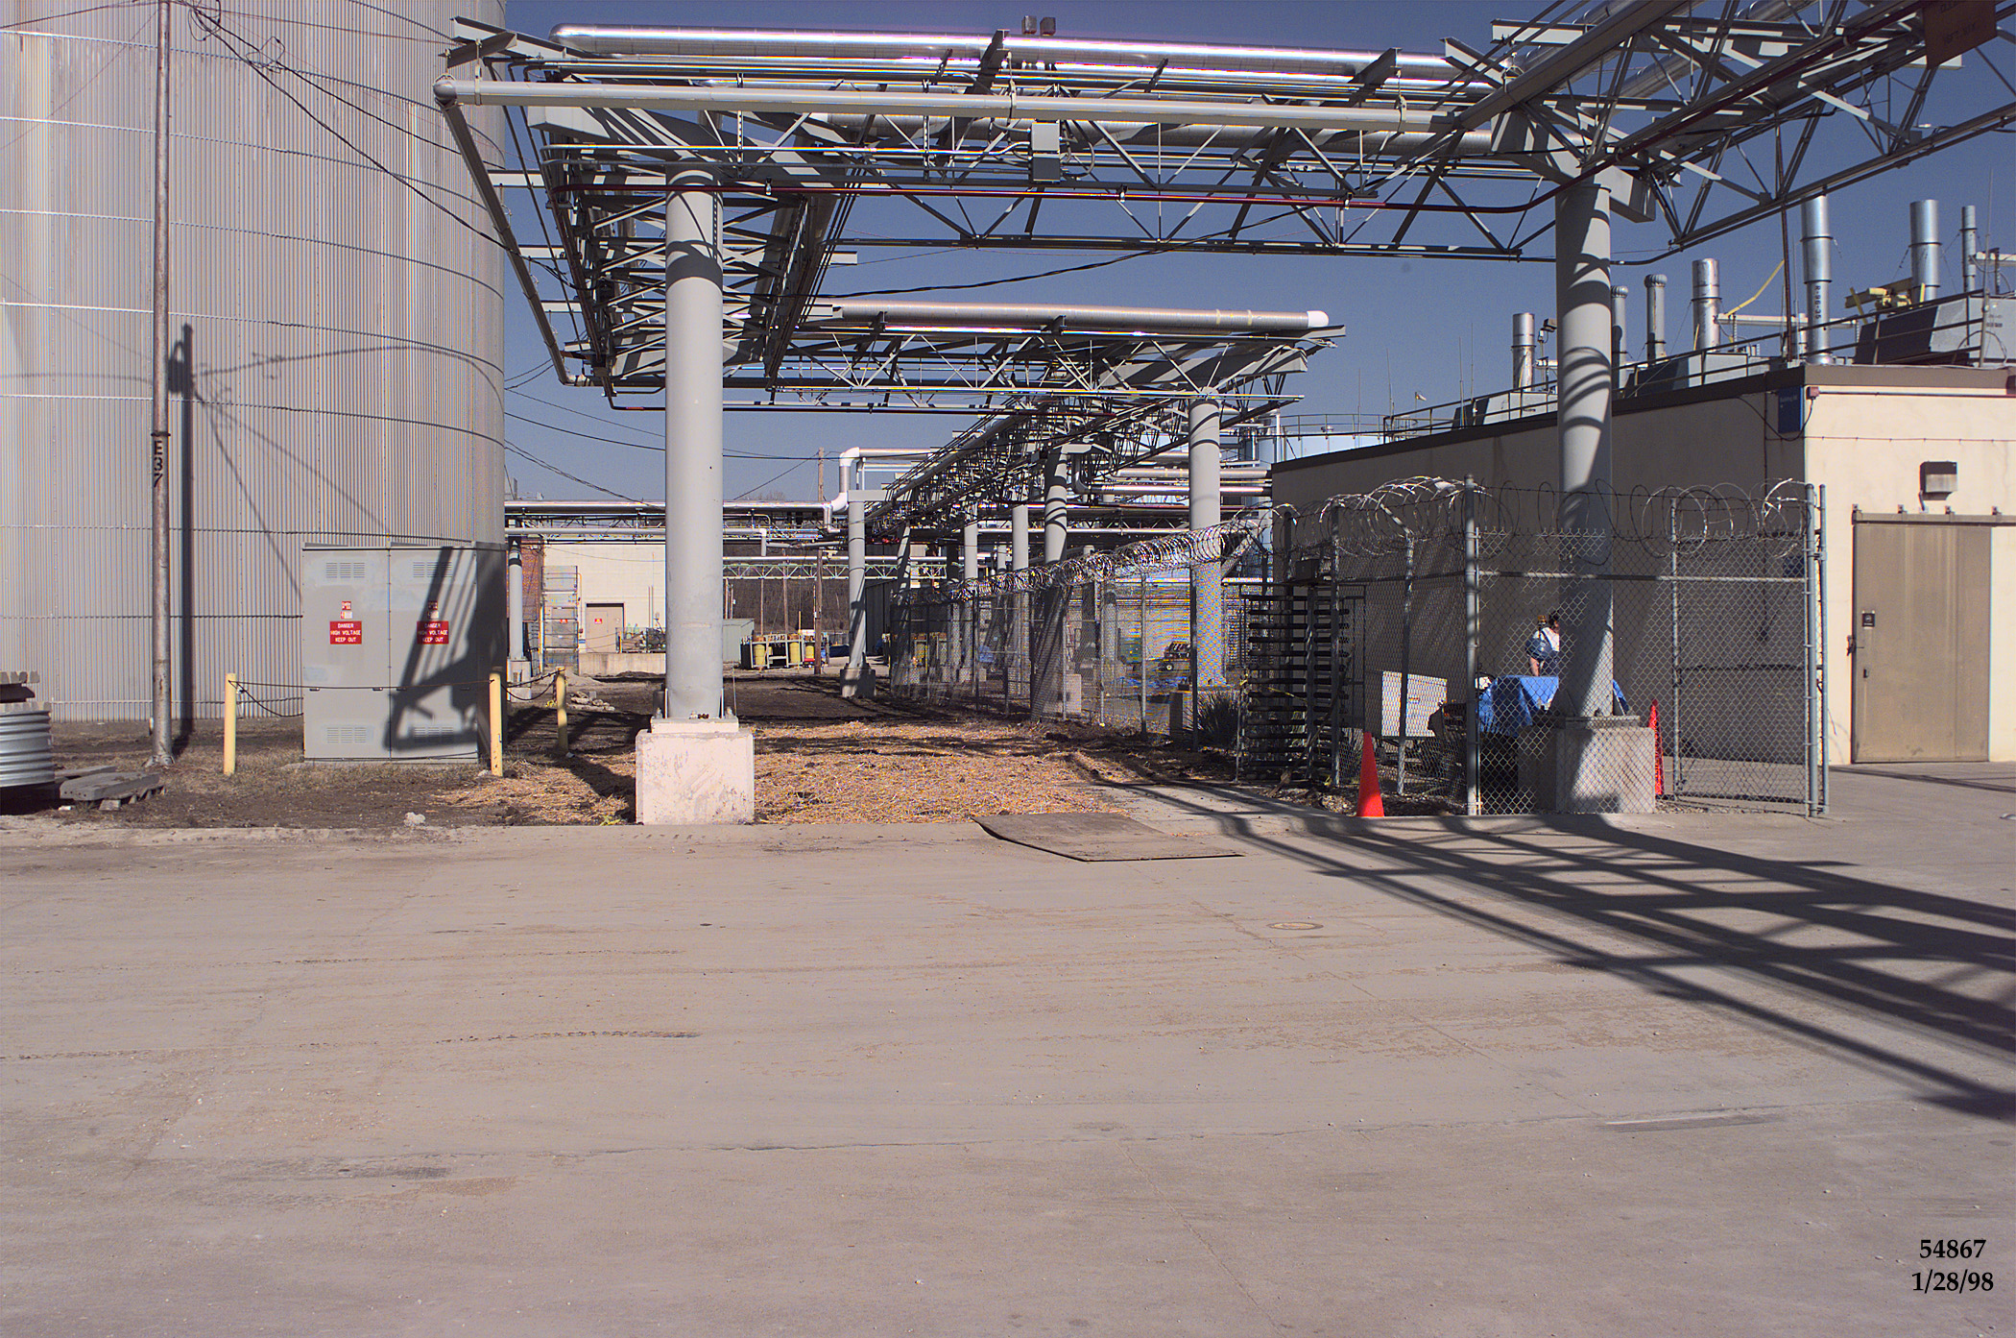
Photograph #54867, 01/28/98

Photograph of completed construction: South Excavation Area after roadway pavement has been replaced; North Slab Removal Area after top soil and seeding has been placed.
